DYNAMIC HOME INSPECTIONS INC.

## PROPERTY INSPECTION

1234 Main Street  
Annapolis, MD 21401

02/25/2023 9:00AM

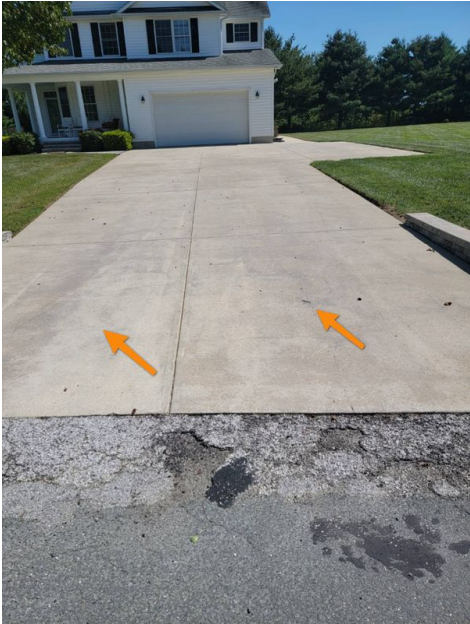
Driveway: Driveway Has Minor Cracking with No Differential Movement

Front  
Minor cracks, no differential movement, seal cracks: The driveway has minor cracks with no differential movement. Seal the cracks to prevent water intrusion. Water expands 9% when it freezes so sealing small hairline cracks when they start keeps them from getting larger

Minor Cracking (Maintenance)

RECOMMENDATION: Seal using single component polyurethane.

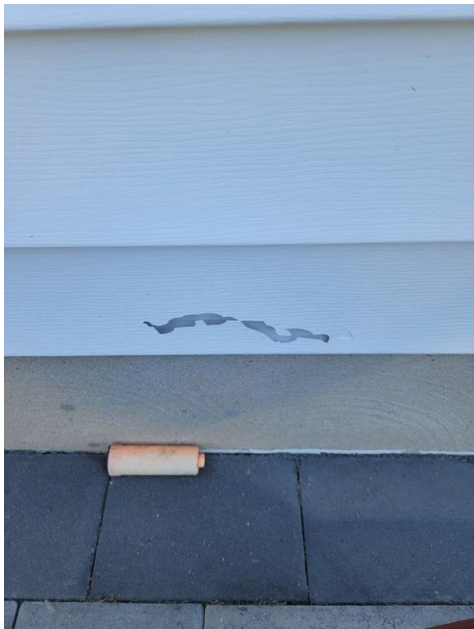
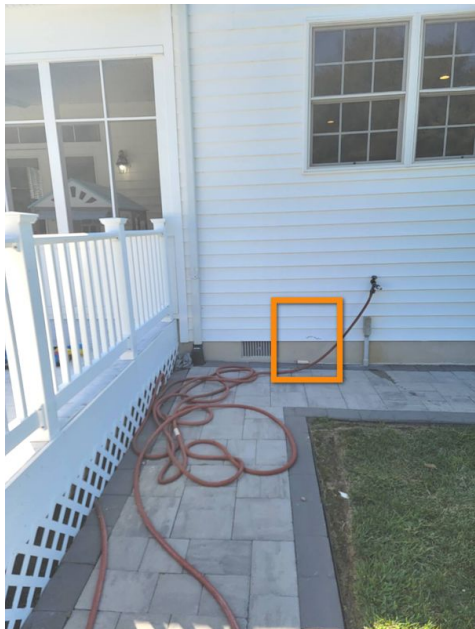
Location Perspective (Rear)

DAMAGED SIDING

There is damaged siding. Damage can allow water to enter but in this area the foundation wall is behind so it's mainly cosmetic but should be noted.

Damaged Vinyl Siding

RECOMMENDATION: Repair or replace the siding.

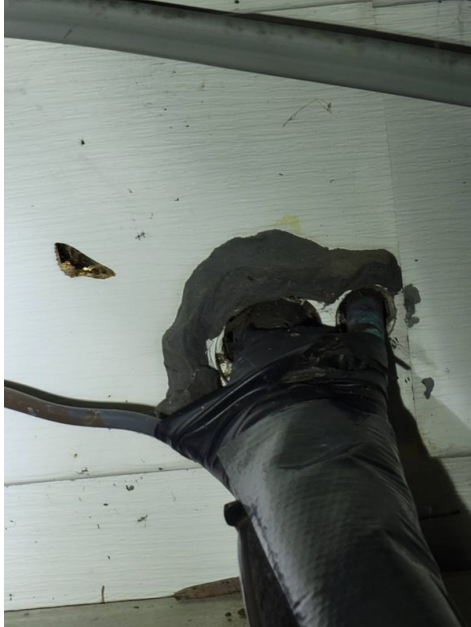
There are gaps or unsealed openings in the siding. Gaps/ unsealed openings can allow water to enter, which can result in further damage.

Gaps needs Sealing

**RECOMMENDATION:** Repair the siding and repair any damage that may be revealed. Use duct seal compound or exterior grade sealant to seal smaller gaps and openings.

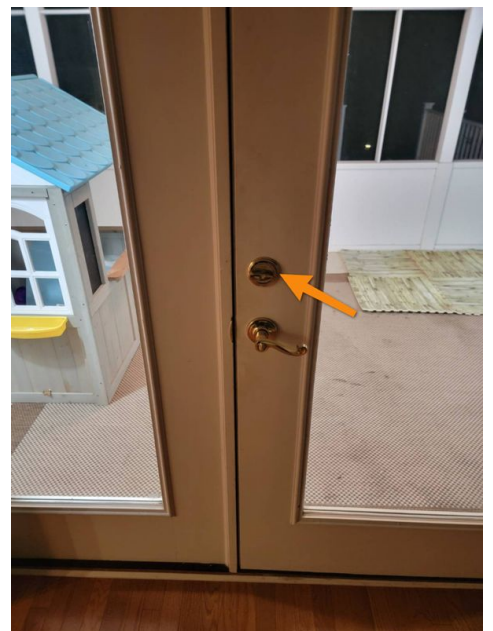
Rear Patio Inside Door Deadbolt doesn't latch

**RECOMMENDATION:** Repair or adjust the door(s) or hardware as needed.

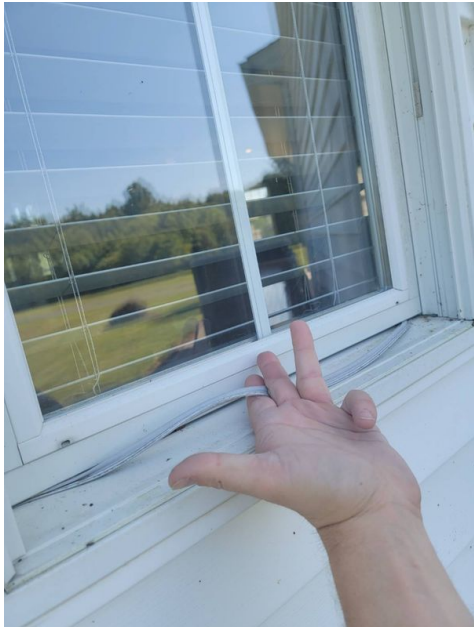
SEALANT STRIP DAMAGED/SHIFTED

Weather Seal Shifted out of place

RECOMMENDATION: Replace the seal under the window as needed.

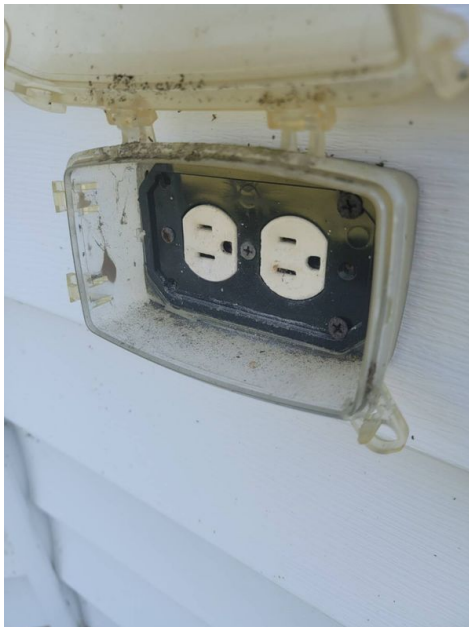
No GFCI Electrical Protection

**RECOMMENDATION:** Consider hiring a licensed electrical contractor to properly upgrade and install a GFCI-protected receptacles.

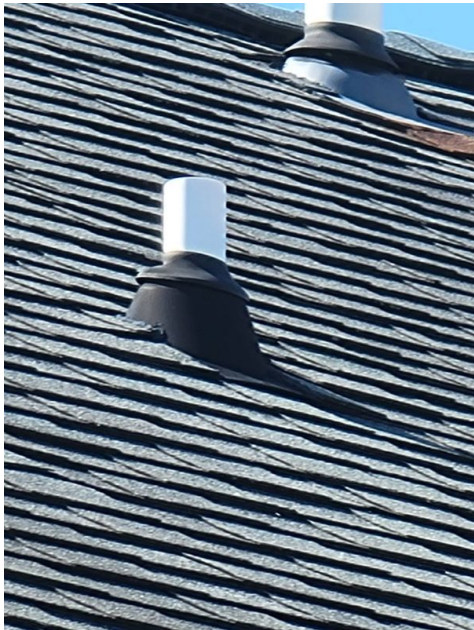
The vent pipe/exhaust vent is too short. Vent pipes should extend a minimum of 6 inches above the roof. The vent become blocked with any significant snow fall will affect drainage inside the house. This is where the plumbing system gets it's make-up air when water goes down the drain/toilets etc. If covered, they will not drain properly.

Vent Pipes too short

RECOMMENDATION: Hire a contractor to extend the vent pipes to at least 6"- 12" would be ideal.

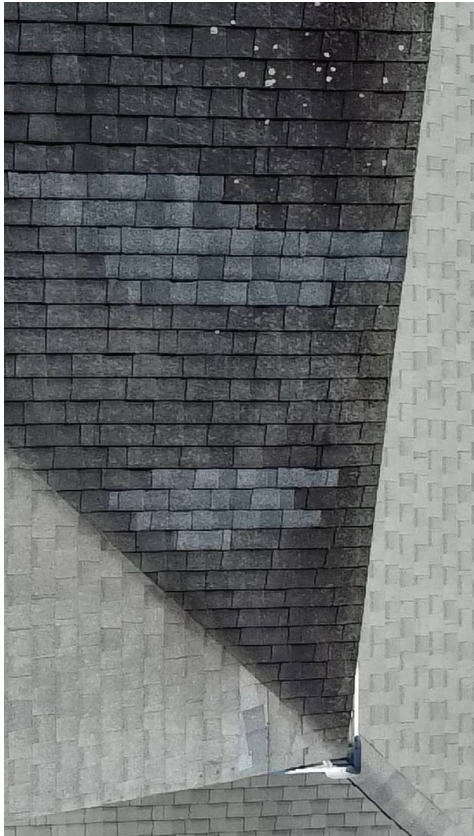
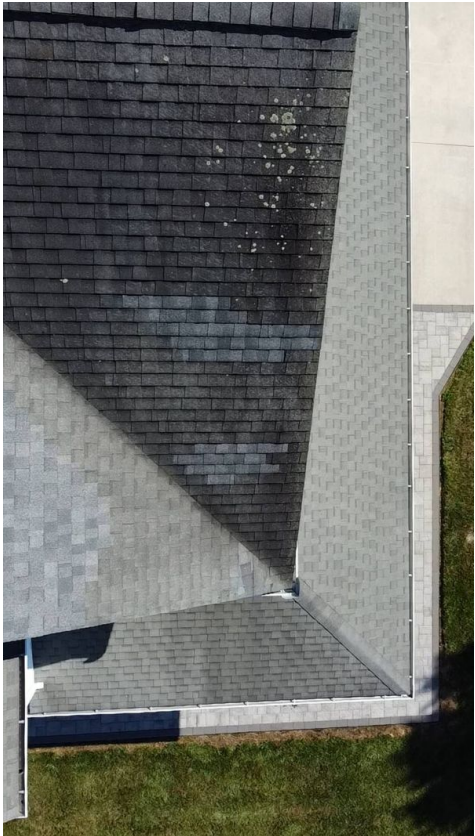
PREVIOUS REPAIRS NOTED

Repairs to Roof

RECOMMENDATION: Monitor the area below the repairs to consider if additional action is required. Hire a qualified roofing contractor for an evaluation as needed.

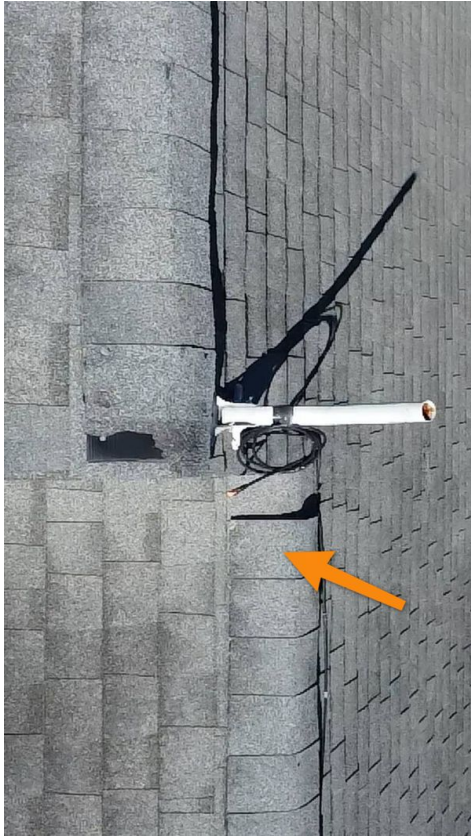
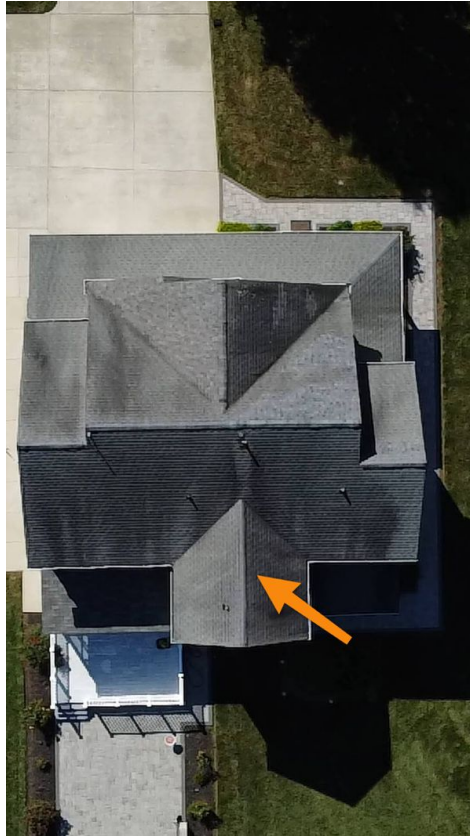
Left Top Side of House

**MISSING/TORN SHINGLE**

There is a missing/torn shingle. Missing shingles can permit water penetration.

Torn/Missing Shingle

**RECOMMENDATION:** Hire a qualified roofing contractor for an evaluation and to replace the missing shingle as needed.

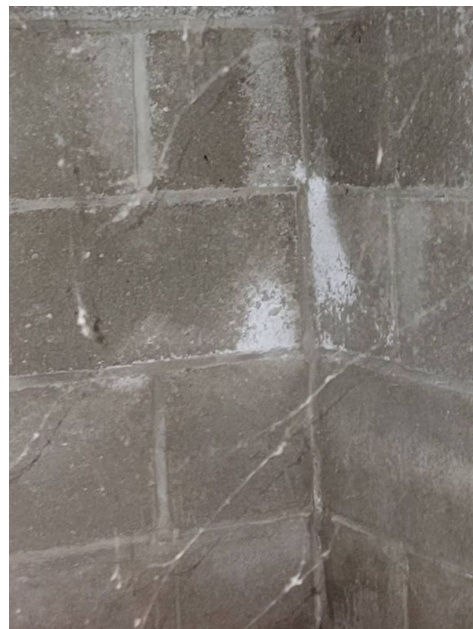
There is efflorescence in the basement or crawl space. These white crystalline deposits indicate moisture penetration. This is conducive to mold formation and damage. The source of the penetration must be identified. If correcting the grading is not possible, seal the gaps against the foundation on the exterior.

Efflorescence White Powder Calcium Carbonate

RECOMMENDATION: Hire a contractor for an evaluation and to make upgrades or repairs as needed.

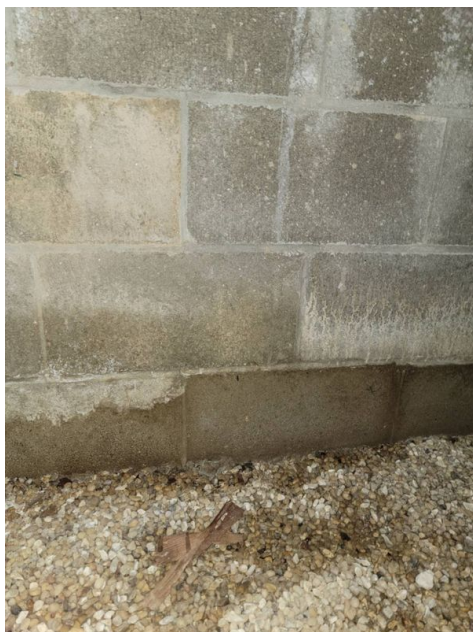
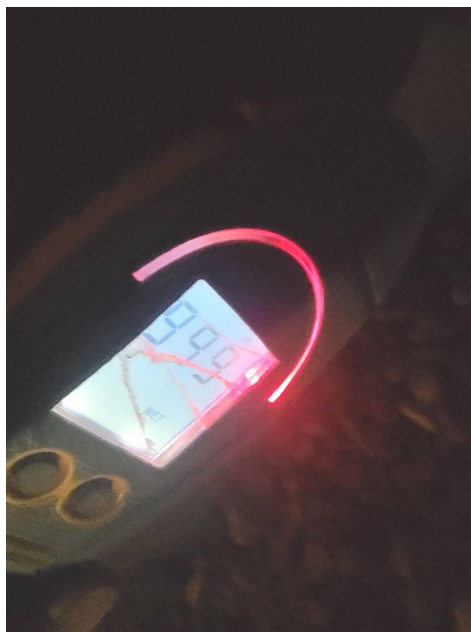
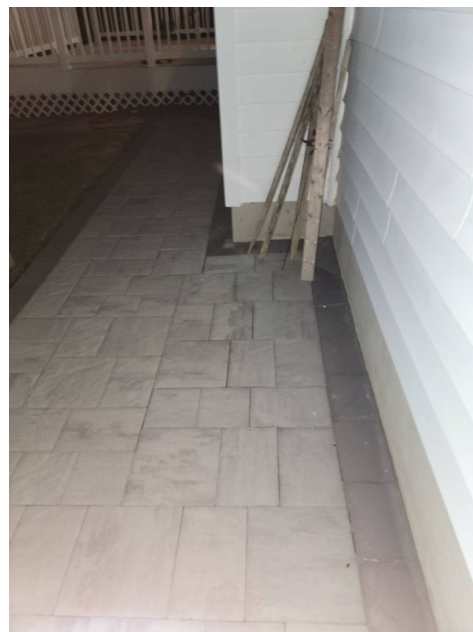
There is water in the basement or crawl space. This is conducive to mold formation and damage. The source of the water penetration must be identified.

Bottom Row is wet

Moisture Meter Showing Wet

Rear Slots between pavers are allowing Water to pass through foundation

RECOMMENDATION: Hire a contractor for an evaluation and to make repairs and upgrades as needed.

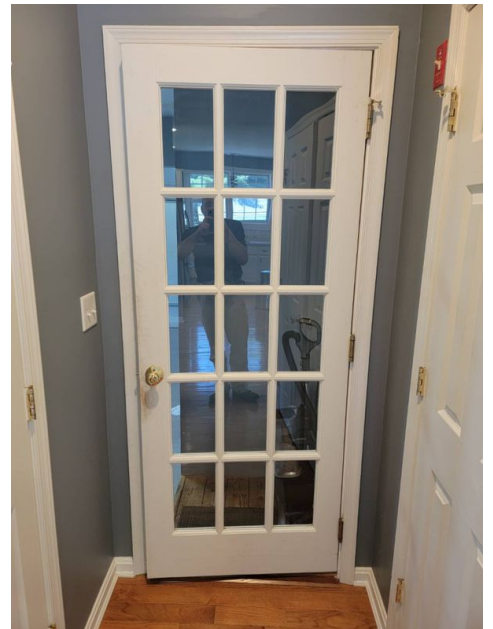
The occupant door from the attached garage to the living space is not fire-rated. In the event of a fire, the occupant door does not afford the required protection until firemen arrive. This is a safety concern.

Garage Occupant Door not Fire Rated

RECOMMENDATION: Hire a contractor to install a fire-rated door.

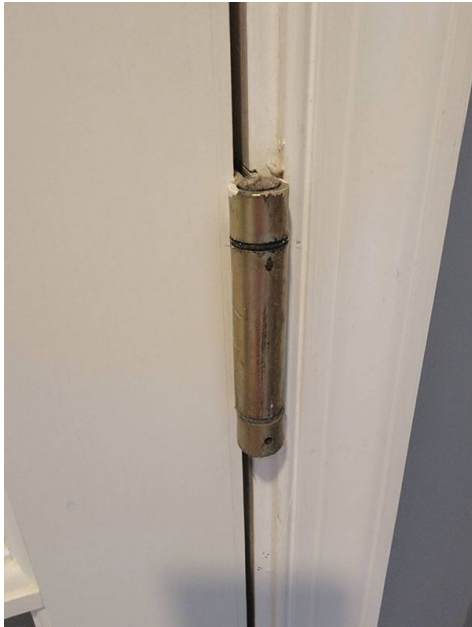
The self-closing hinges on the door between the attached garage and the living space is damaged or the tension has been removed. The door does not fully close on its own. This is a safety concern. It can allow gas fumes and carbon monoxide to enter the living space.

Self-Closing Hinges Exists

RECOMMENDATION: Adjust or replace the self-closing hinges.

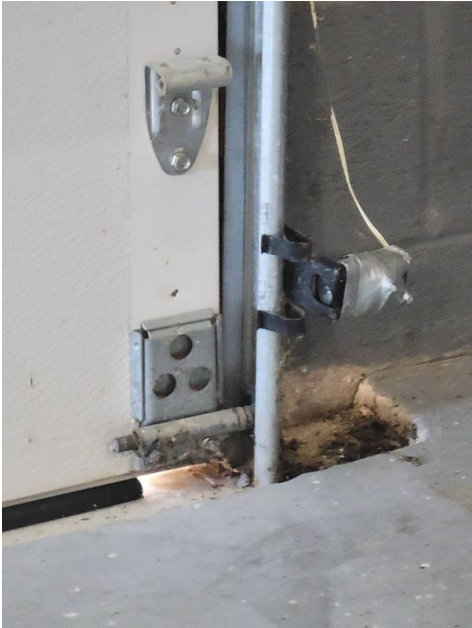
The garage door totally electric auto reverse sensor may be damaged. It is wrapped in tape. The reason for this is unknown but may indicate that there is or has been issues with the photoelectric sensor functionality.

Taped Photoelectric Auto reverse sensor Taped

RECOMMENDATION: Hire a garage door specialist to evaluate and make repairs as needed.

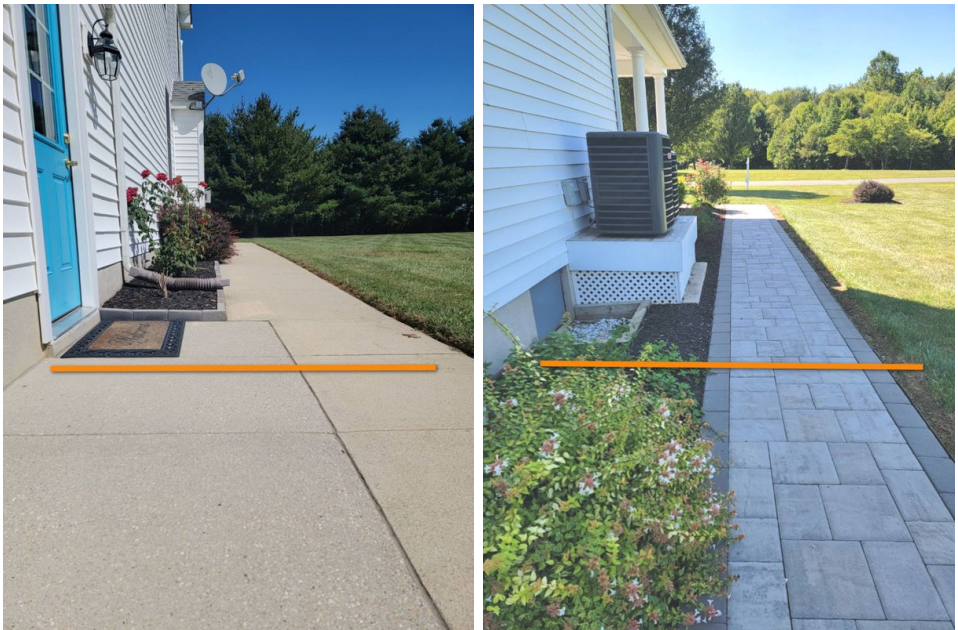
Neutral Grading no positive slope away from Foundation

RECOMMENDATION: Re-grade to divert surface water away from the foundation. The grade should be sloped at 1" per foot for up to 6' from the dwelling.

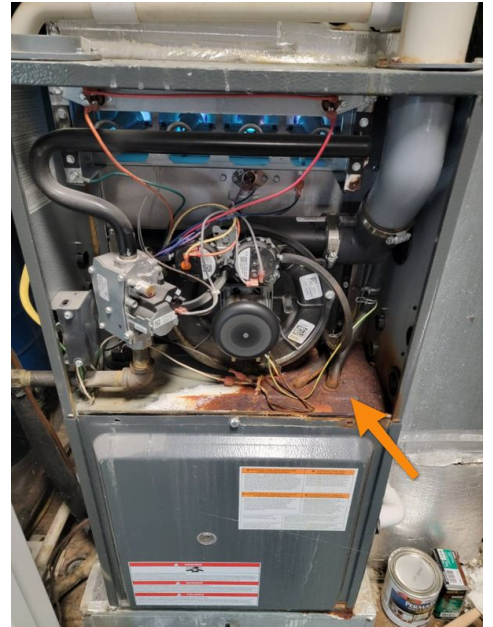
There is excessive corrosion on the heating system behind the panel. The cause of the corrosion needs to be identified and corrected. This can leak directly on electrical components below and is a safety concern. Turned system off to prevent further damage possible to the electronic control board below.

Excessive Corrosion from Water

**RECOMMENDATION:** Hire an HVAC contractor for an evaluation of the system and to make the required repairs.

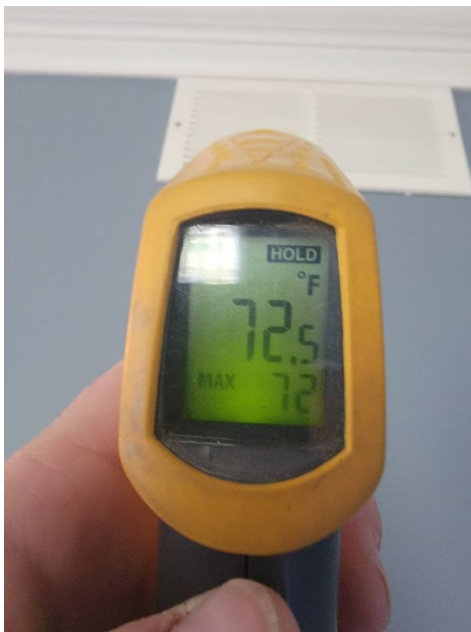
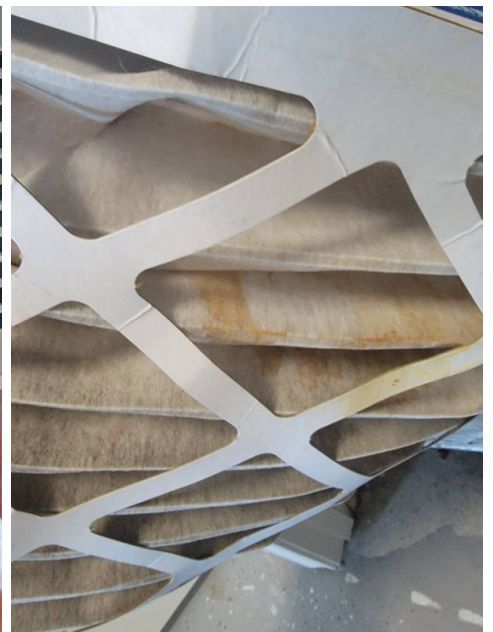
NOTE: Turned the AC off in the case of a restriction or low refrigerant. This could keep the proper oil return back to the compressor and allow it to burn out. This would be a much larger cost.

Return Temperature

Supply Temperature Drop Excessive

Water Staining on Filter indicates (Coil Freezing/Melting)

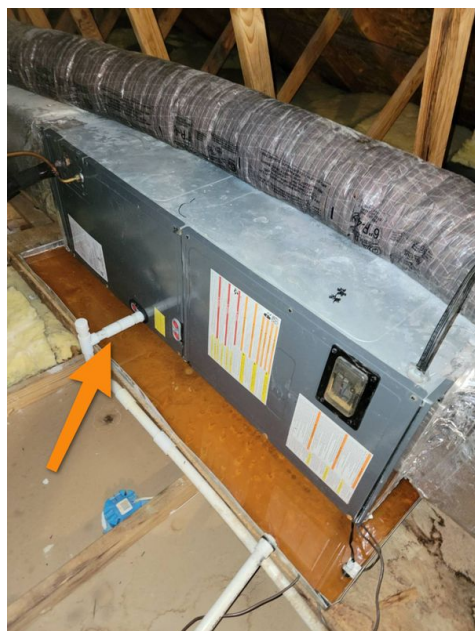
Drain needs clearing here

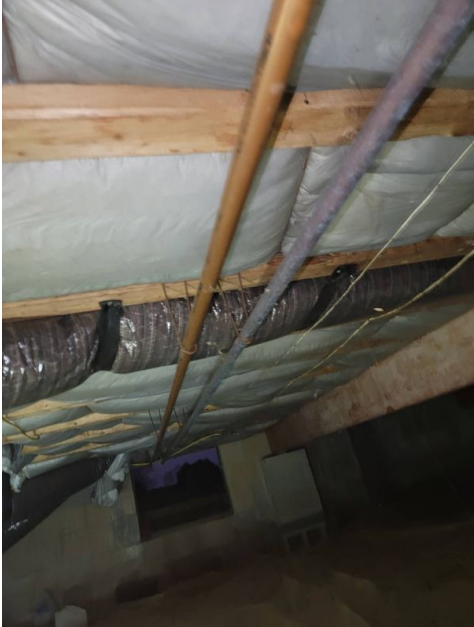
Under Floor Insulation installed Backwards

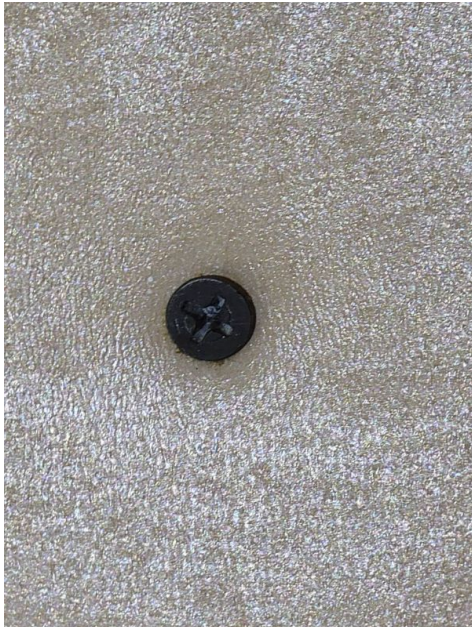
The cabinets are not properly secured. They are secured using deck/drywall screws. These do not have the tensile strength of approved fasteners/cabinet anchors. This is a safety concern.

Drywall Screws Securing Cabinets

RECOMMENDATION: Secure the cabinets using approved fasteners.

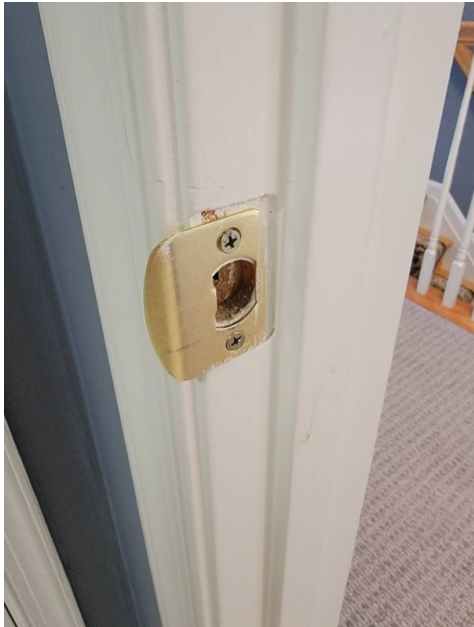
Strike Plate needs Adjustment

RECOMMENDATION: Repair or adjust the door(s) or hardware as needed.

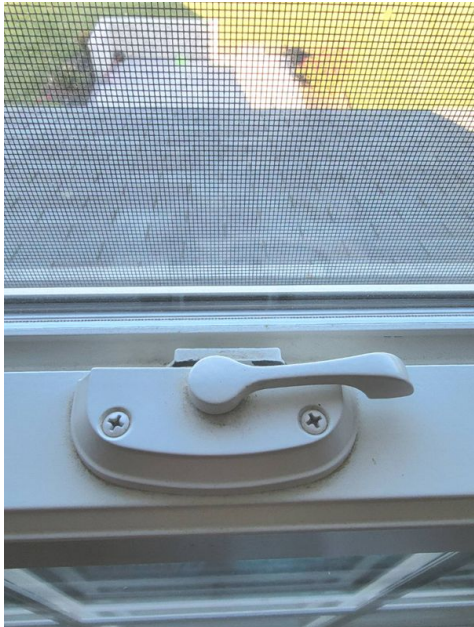
Window hardware doesn't line up fully to latch. This affects the proper function.

Latch doesn't line up to latch properly

RECOMMENDATION: Try adjusting window first. If unsuccessful repair or replace any damaged or inoperative hardware. Hire a window contractor as needed.

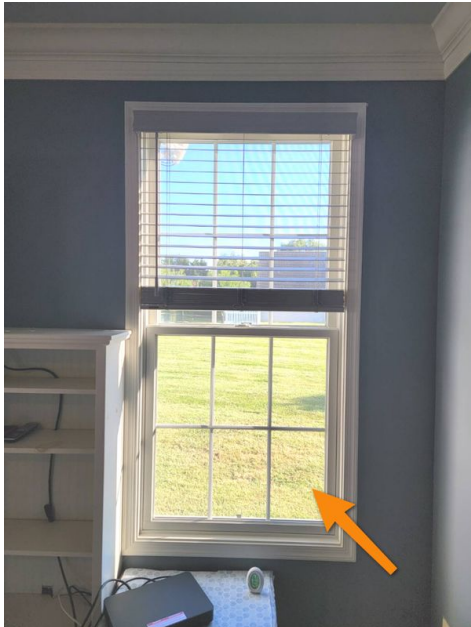
Lower Sash won't stay open(Needs Adjustment)

RECOMMENDATION: Hire a licensed window contractor to replace the window(s) as needed.

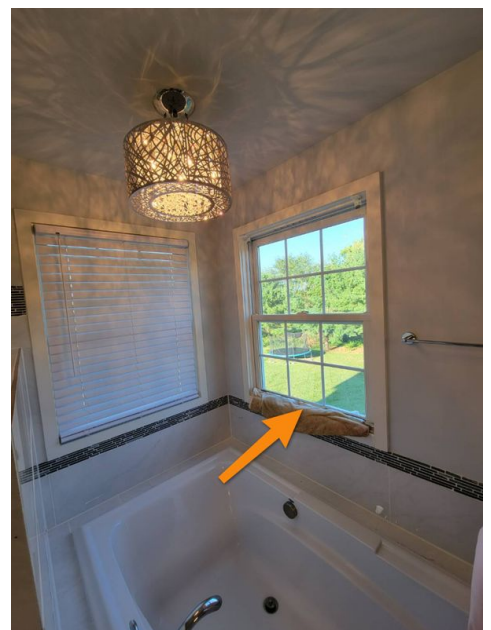
Left Rear Master Bathroom

The window sash is damaged and doesn't seal properly when the window is closed. This can permit air and possibly water to enter.

RECOMMENDATION: Replace the window/ sash.

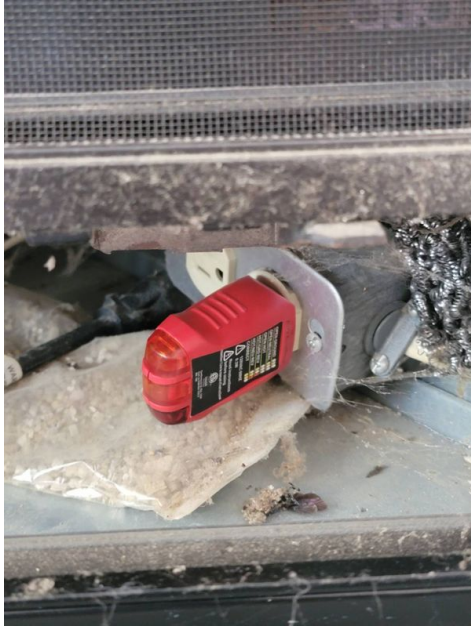
The gas fireplace insert is inoperative. It did not respond to normal operating controls at the time of inspection. This prevents normal use.

No Power going to Fireplace

**RECOMMENDATION:** Hire an electrician to evaluate and make repairs as needed to get power to the fireplace. This may not be the only issue but chances of more than 1 thing going wrong at the time are very unlikely.

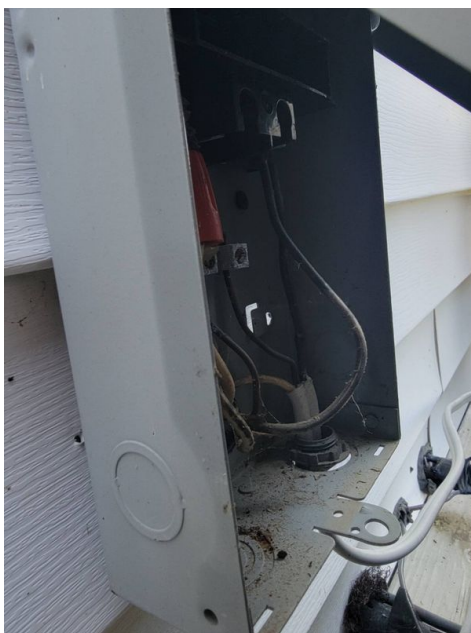
Missing Cover Plate (Leaving Exposed Wiring Accessible)

RECOMMENDATION: Hire an electrician to make repairs as necessary.

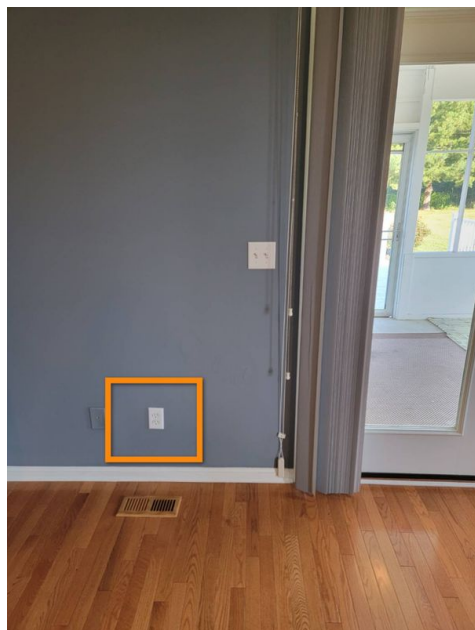
Rear Wall near porch

Receptacles are loose in the wall or in their junction boxes. This is a safety concern. Loose receptacles can result in damaged or loose the wire connections.

RECOMMENDATION: Hire a licensed electrical contractor for an evaluation and to provide repairs as needed.

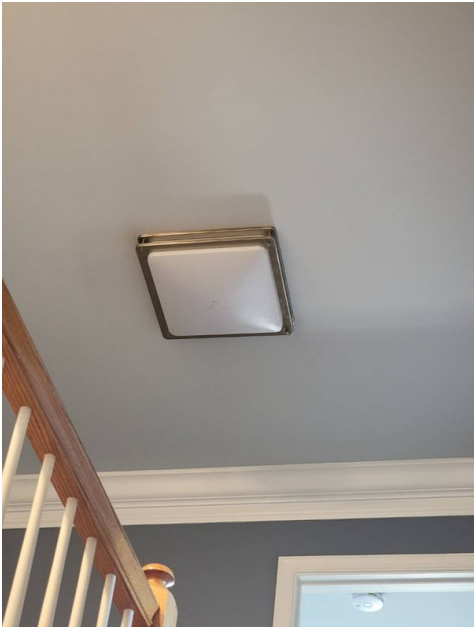
Inoperative Light Fixture (Upstairs Hallway)

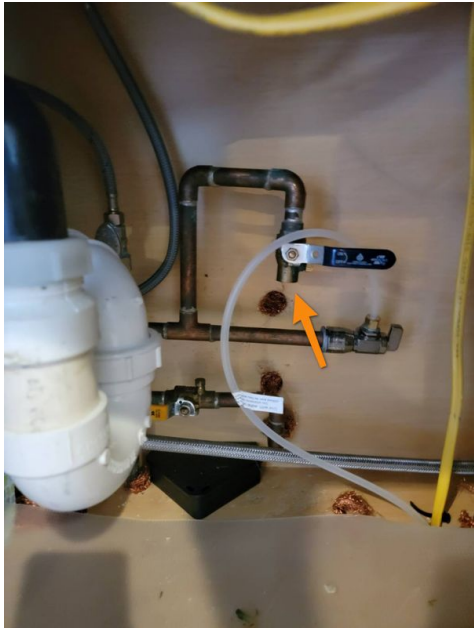
Copper Water Line needs Capping

RECOMMENDATION: Hire a plumber to properly install a cap after the valve.

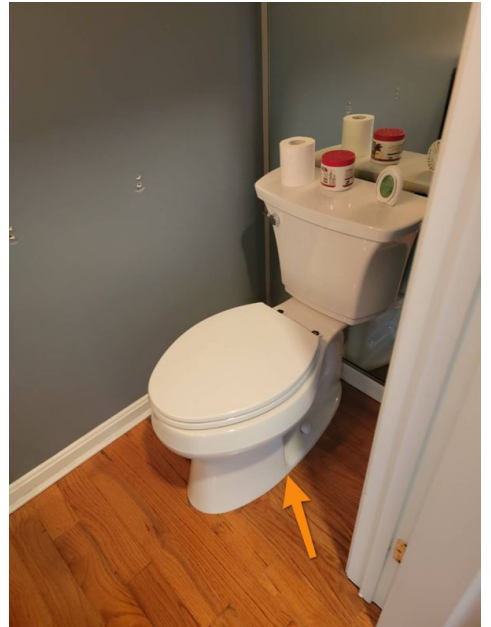
Loose at Base (Replace wax ring and Resecure)

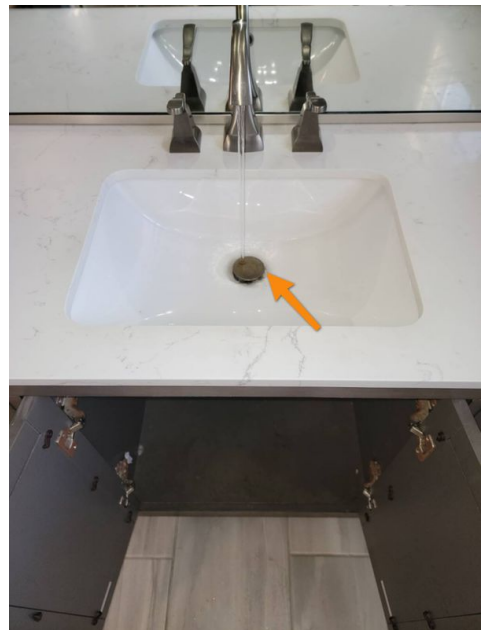
Stopper needs adjustment

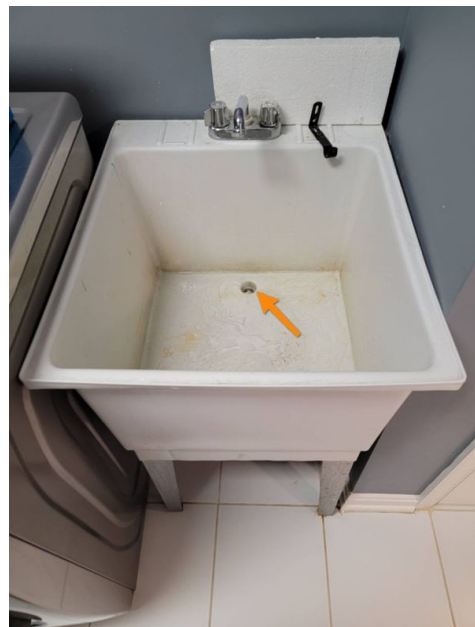
The sink is slow to drain. This prevents proper function.

Slow to Drain

**RECOMMENDATION:** As part of a home inspection, the exact condition of the interior of the plumbing pipes could not be determined. Hire a licensed plumber to evaluate the system and make repairs.

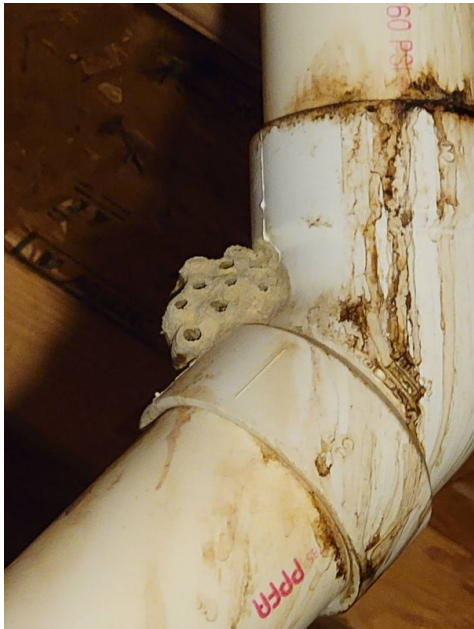
Evidence of past bee or wasp hive or nests were observed in the attic. They were getting in where the furnace PVC Flue pipe has been disconnected.

Bees or wasp evidence of past activity

RECOMMENDATION: This is past evidence and no action is required. No live insects seen.

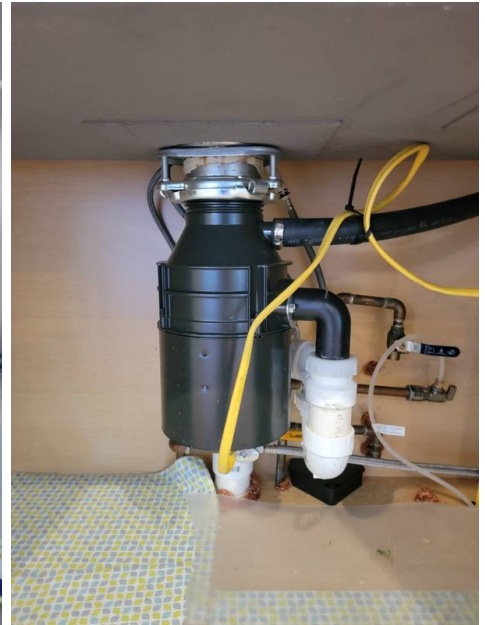
Garbage Disposal on Septic(Not  
Recommended)

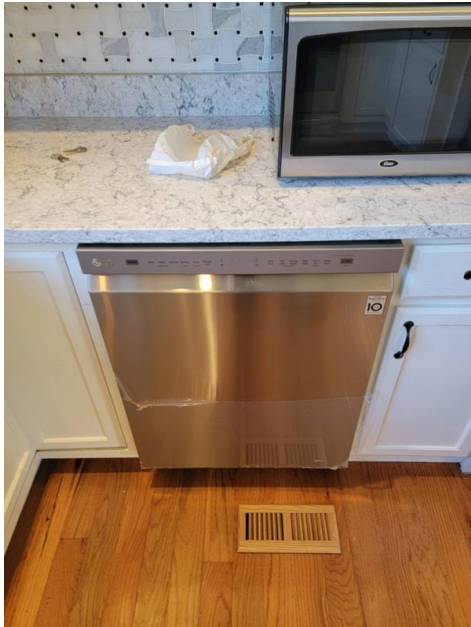
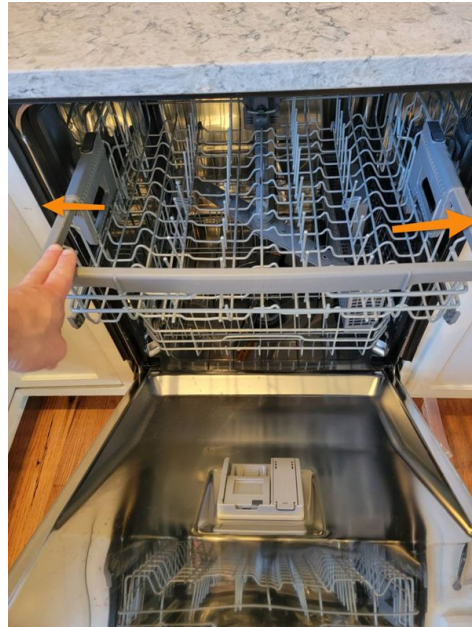
The dishwasher is not properly secured to the sides. Not able to anchor to the countertop since it's screws can't penetrate. Dishwasher moves excessively. This can cause a water leak.

Dishwasher is Loose(Not anchored)  
Functional

Anchoring screws go in the predrilled  
holes here

**RECOMMENDATION:** Hire an appliance technician to properly secure the dishwasher to the sides so that it does not move and check the water line connection to make sure it's free of leaks after securing properly.

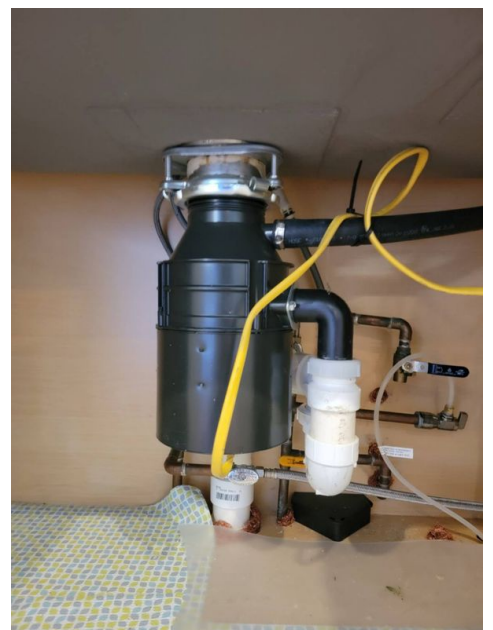
The garbage disposal is excessively noisy. This typically indicates a failing and unreliable appliance.

Disposal Noisy

**RECOMMENDATION:** Clean, repair or replace the disposal.

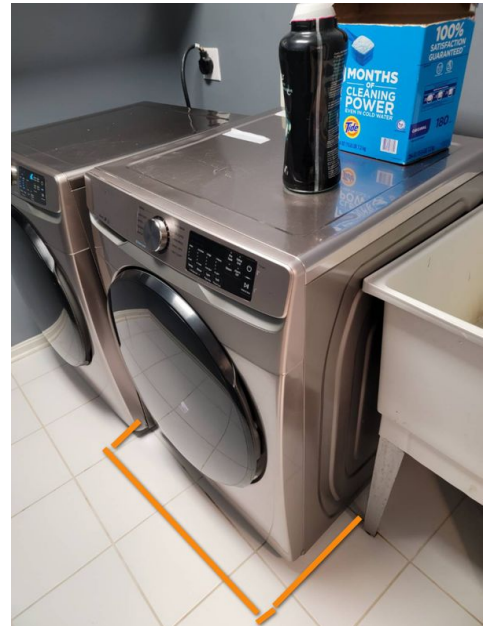
Missing Water Catch Pan
