DYNAMIC HOME INSPECTIONS INC.

## PROPERTY INSPECTION

1234 Main Street  
Annapolis, MD 21401

02/25/2023 9:00AM

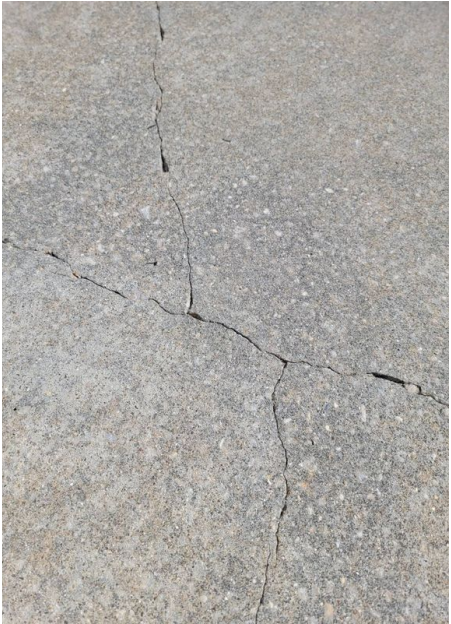
Driveway: Driveway Has Minor Cracking with No Differential Movement

Front  
Minor cracks, no differential movement, seal cracks: The driveway has minor cracks with no differential movement. Seal the cracks to prevent water intrusion. Water expands 9% when it freezes so sealing small hairline cracks when they start keeps them from getting larger

Minor Cracking (Maintenance)

RECOMMENDATION: Seal using single component polyurethane.

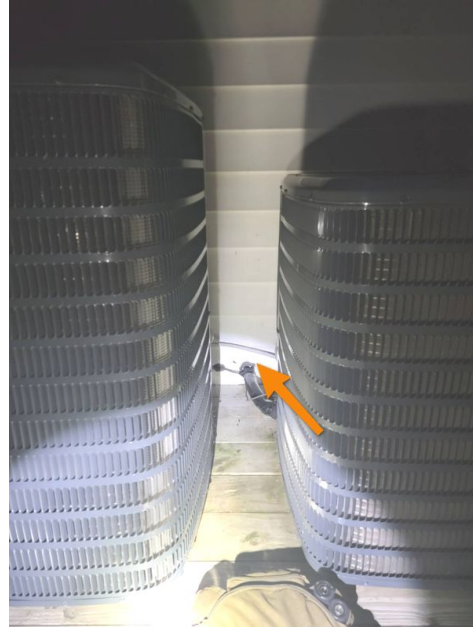
Wall Between both HVAC outdoor units

There are gaps or unsealed openings in the siding. Gaps/ unsealed openings can allow water to enter, which can result in further damage.

**RECOMMENDATION:** Repair the siding and repair any damage that may be revealed. Use duct seal compound or exterior grade sealant to seal smaller gaps and openings.

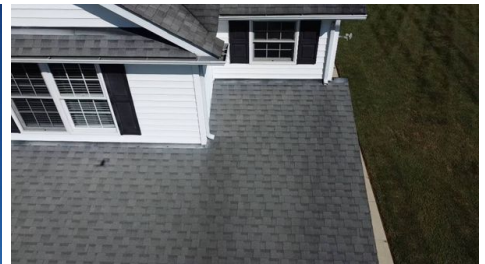
Roof in Serviceable Condition

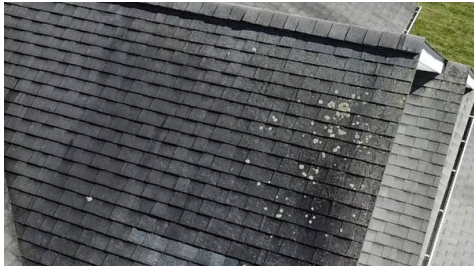
There is biological growth on the roof covering. Moss, lichens, fungus, or other biological growth can damage the roof covering and cause premature deterioration or failure.

Biological Growth Needs Cleaning

RECOMMENDATION: Clean the roofing. Hire a contractor to soft wash the roof. The use of a power washer is not recommended as it can dislodge granules and damage the roof covering.

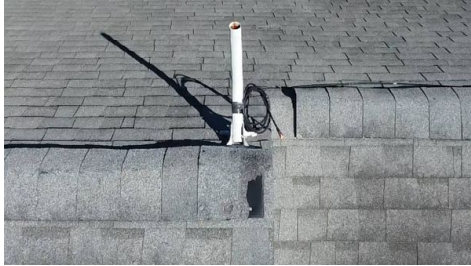
There is a satellite dish or TV antenna attached directly to the roof covering. If fasteners are not properly sealed, water penetration can occur which can result in further damage.

Base for TV Dish still on roof

RECOMMENDATION: Monitor this area frequently for water penetration. Consider relocating the equipment. Hire a qualified roofing contractor as needed.

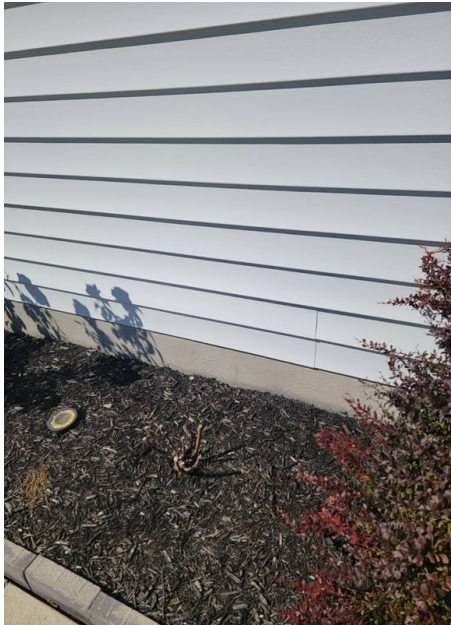
Limited View

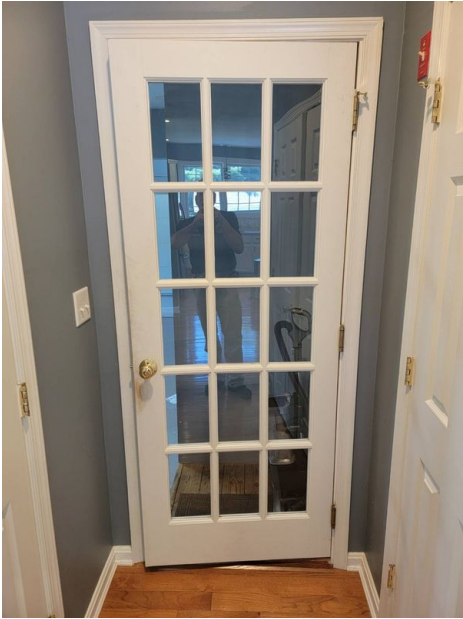
Garage Occupant Door (See  
Comments)

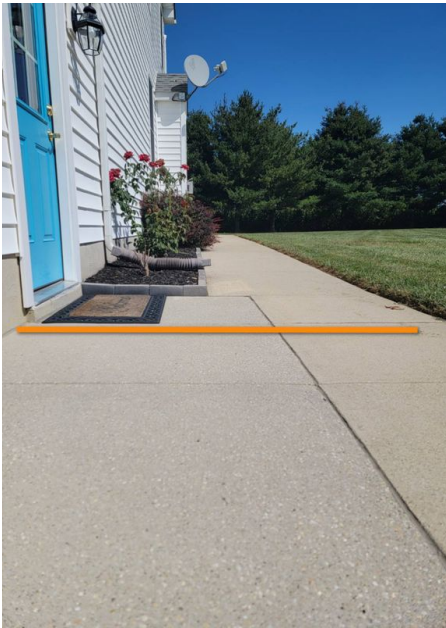
Grading(Right Side) Neutral -See Comments

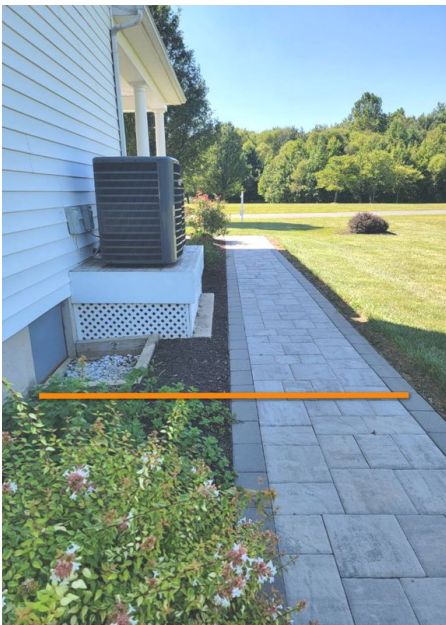
Grading(Left Side) Neutral -No positive slope away from Foundation

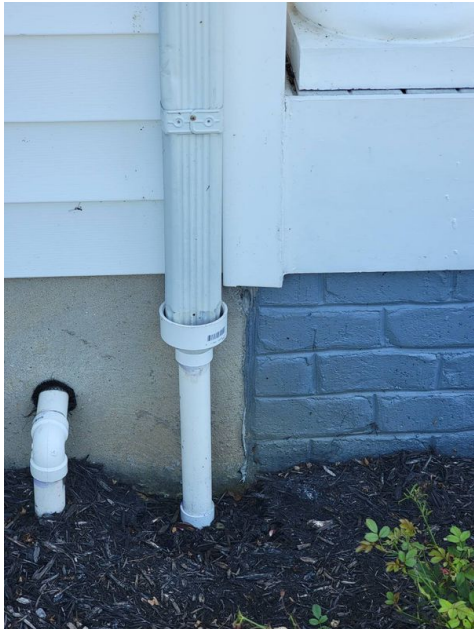
LEFT SIDE

Discharge into underground drainage system: Downspout(s) discharge into an underground drainage system. The condition of underground portions of the drainage system cannot be inspected.

Downspout discharges below grade limits inspection

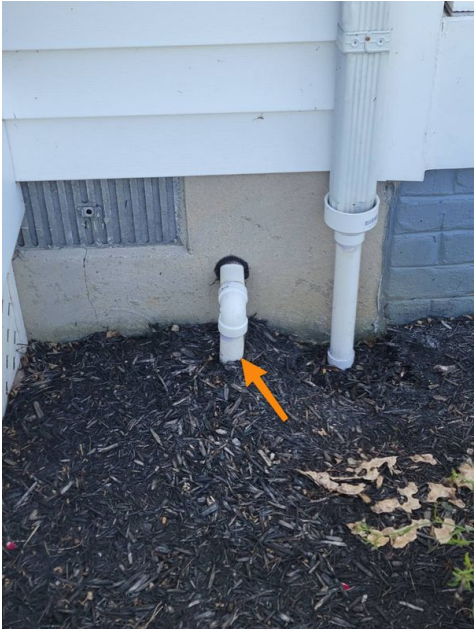
LEFT SIDE OF CRAWL SPACE

Discharge point not visible: The point of discharge for the sump pump is not visible and, therefore, is can not be inspected.

Discharge Below Grade Limits Inspection

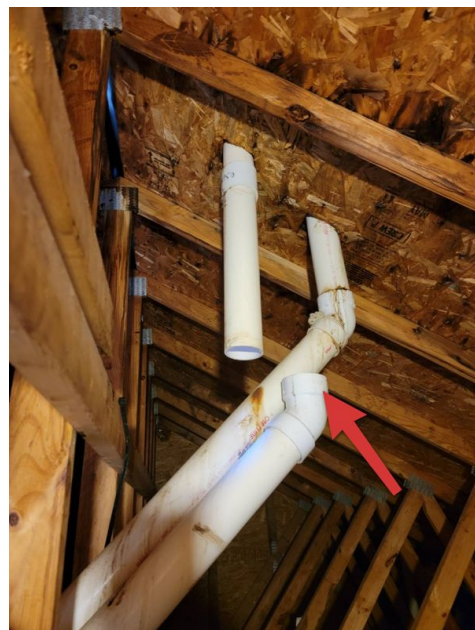
The Heating Systems PVC exhaust flue is venting into the attic. This will allow Carbon Monoxide to enter the home as well as excessive moisture to enter the attic area. This is a safety hazard and the moisture can lead to premature deterioration of structural members in the attic and make conditions conducive to mold growth.

Safety Concern

Must Be Reconnected before using the furnace downstairs

RECOMMENDATION: (Do not use the furnace until flue in attic has been repaired and reconnected to vent to the exterior (out the roof) properly.

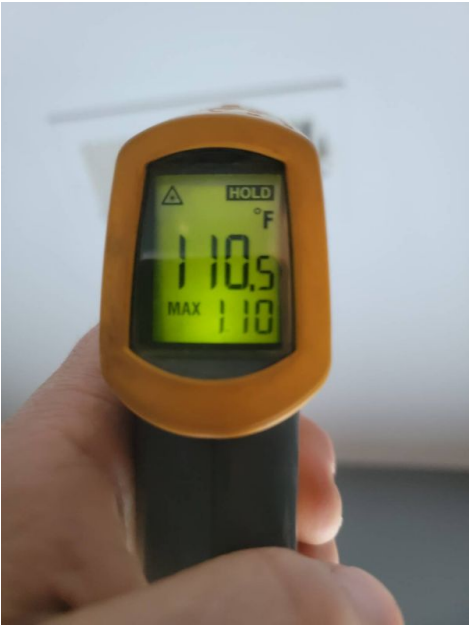
Water Safety Device not Functioning

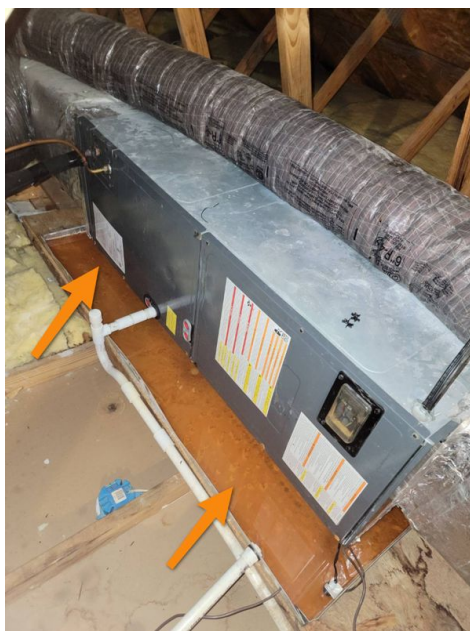
The primary condensate discharge line may be blocked or clogged. This is permitting water to overflow into the catch pan directly below. The drain most likely needs clearing but should be further evaluated by an HVAC contractor before running the Air Conditioning upstairs due to the potential of water damage to the areas below.

Drain needs clearing here

**RECOMMEND:** Have an HVAC contractor clear the drain line and confirm there are no other issues contributing to the water overflowing in the catch pan.

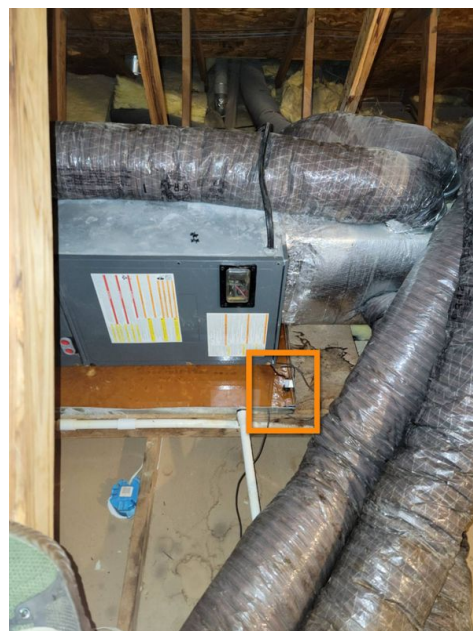
An inch of standing water in catch pan

Water Cut-off switch not working to shut off system properly

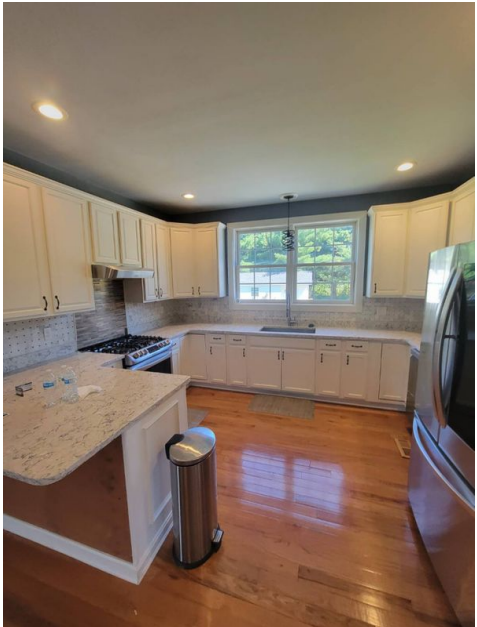
All Cabinets need to be Secured Properly

RECOMMENDATION: Secure the cabinets using approved fasteners.

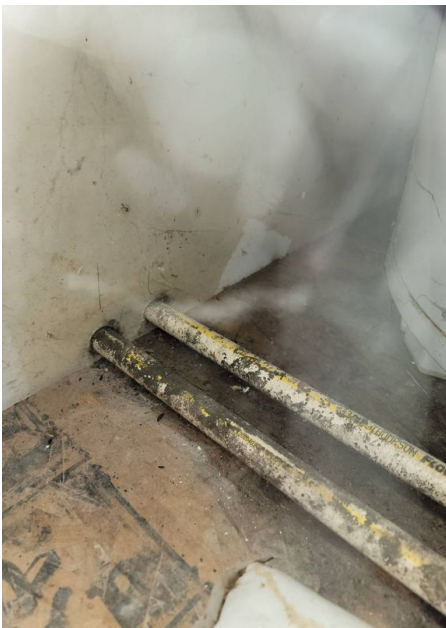
CPVC Water Distribution Lines

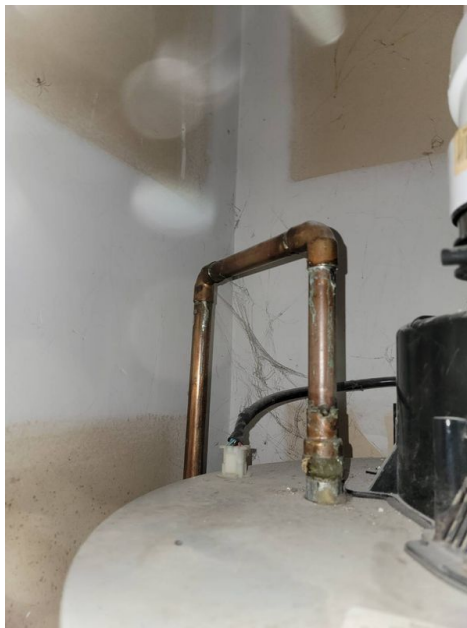
Copper Water Distribution Lines

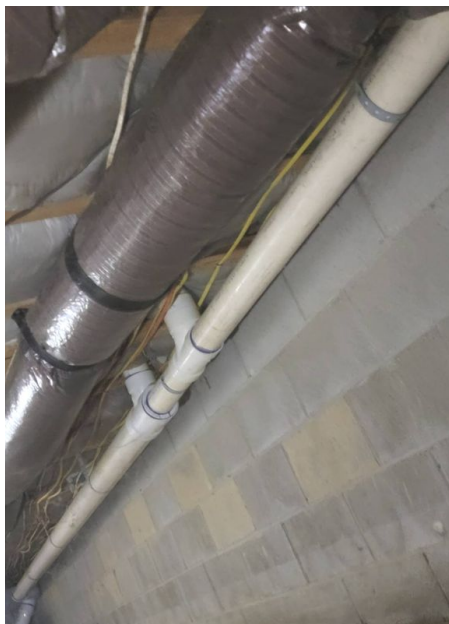
Drain Waste Pipes PVC Pitched Properly

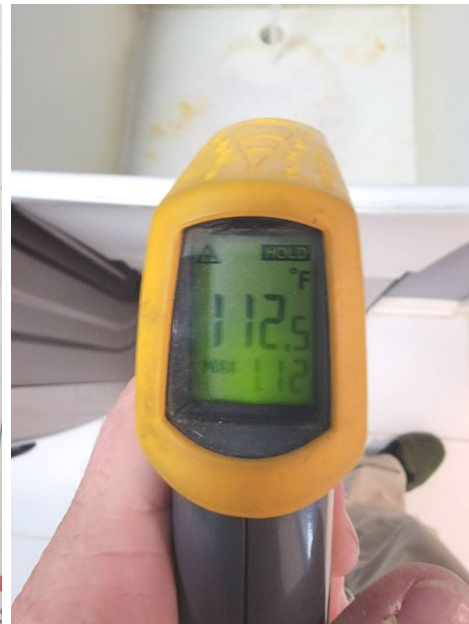
Hot Water Temperature Acceptable

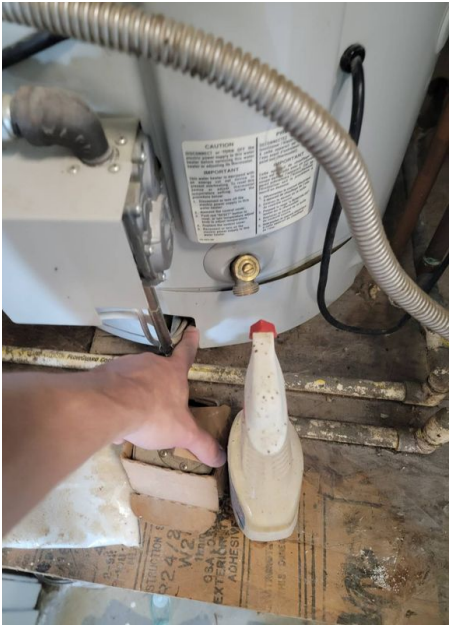
INFORMATION: The water heater is a flame and vapor ignition resistant (FVIR) type water heater with a sealed burner chamber.

FVIR Propane Tank

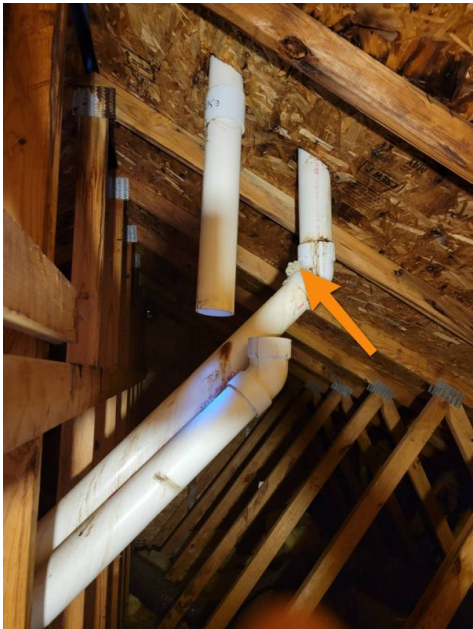
Attic Flue Pipe

Evidence of past bee or wasp hive or nests were observed in the attic. They were getting in where the furnace PVC Flue pipe has been disconnected.

RECOMMENDATION: This is past evidence and no action is required. No live insects seen.

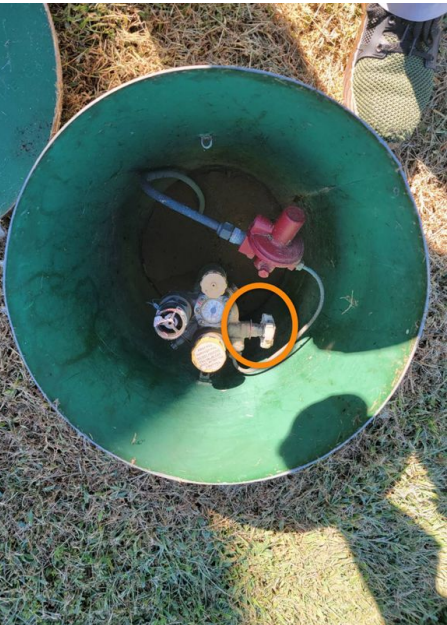
Underground Propane Tank and Main Shut-off Valve

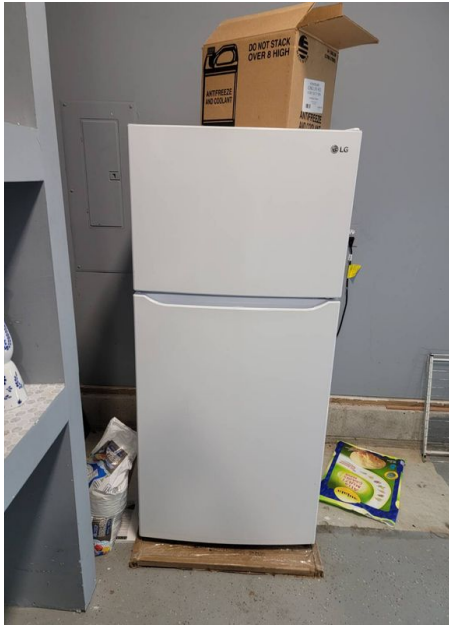
Refrigerator/Freezer Functional  
(Garage)

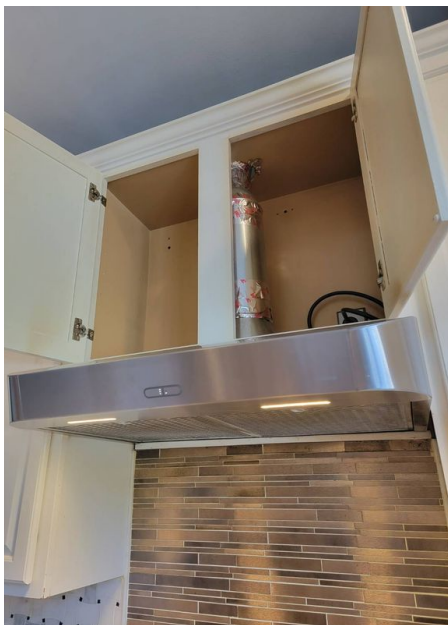
Ventilation Overhead External  
Discharge
