DYNAMIC HOME INSPECTIONS INC.

## PROPERTY INSPECTION

1234 Main Street  
Annapolis, MD 21401

02/25/2023 9:00AM

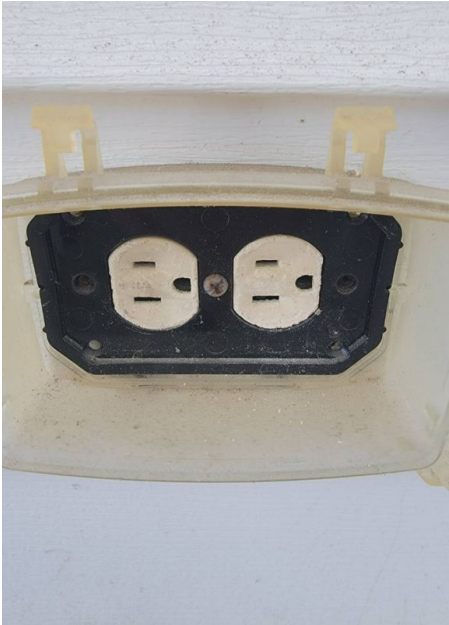
Exterior Receptacles(See Comments)

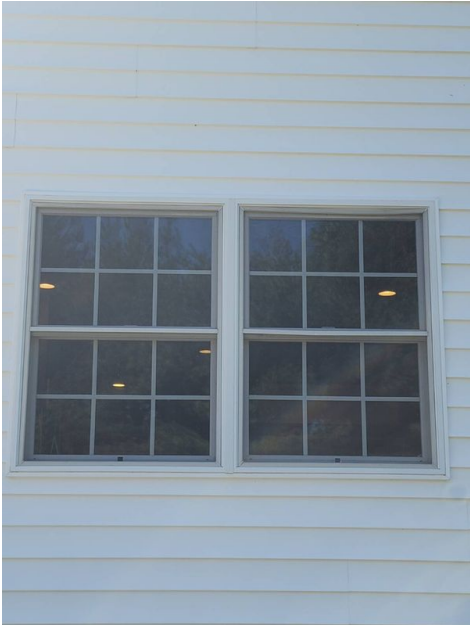
Exterior Windows(See Comments)

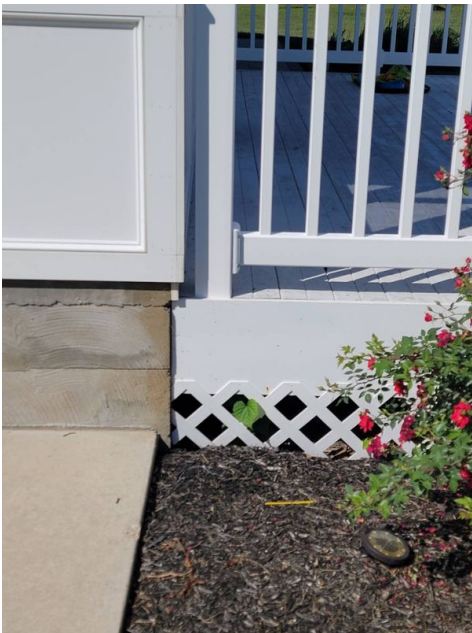
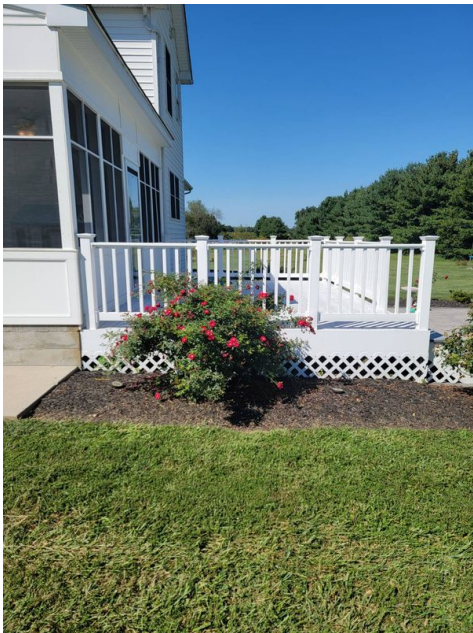
BELOW REAR DECK

LIMITATIONS: The deck cannot be properly inspected because a covering material (e.g., carpet, rug, lattice or other material) prevents unobstructed access. Therefore, the inspection is limited.

Lattice Restricts Inspection Below Deck All around Bottom

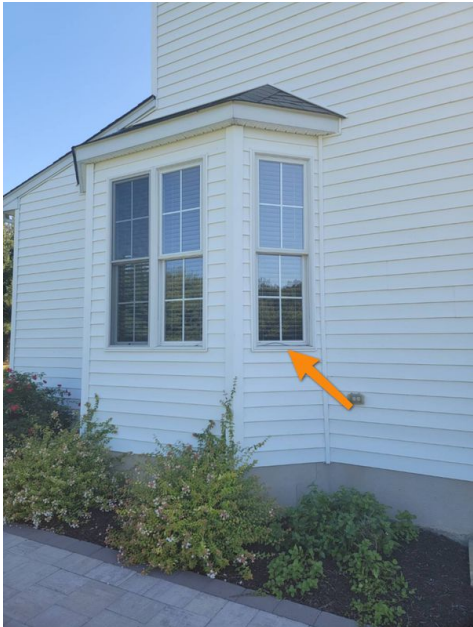
Location Perspective (Left Side)

SEALANT STRIP DAMAGED/SHIFTED

RECOMMENDATION: Replace the seal under the window as needed.

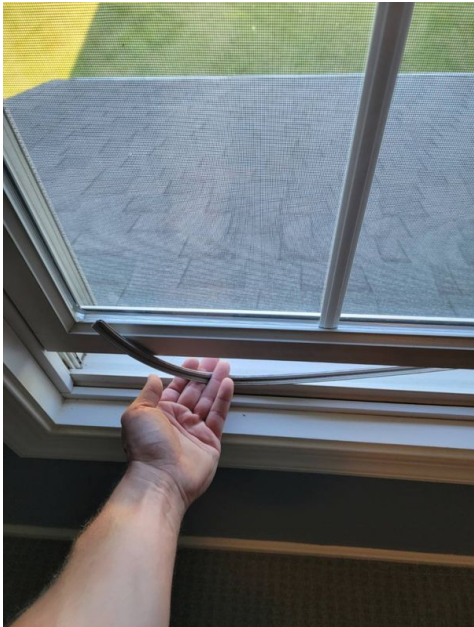
Gasket Shifted

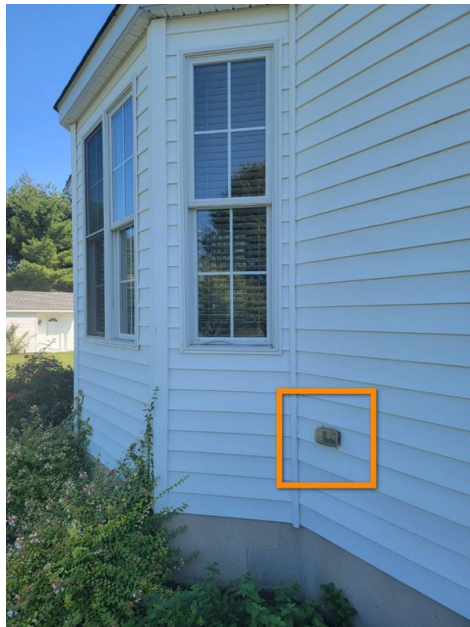
Left Side

No GFCI Electrical Protection

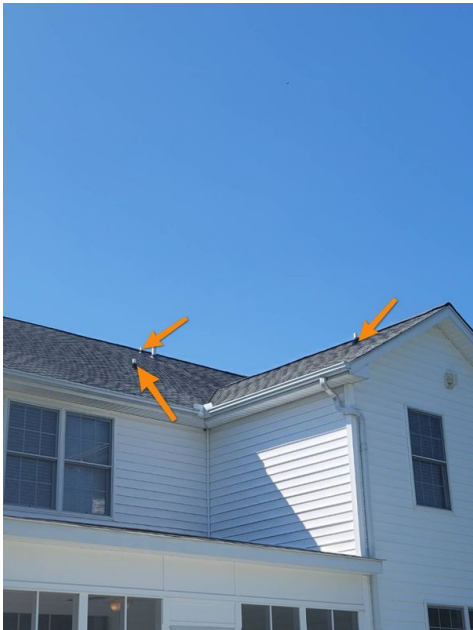
Three in rear should be extended

RECOMMENDATION: Hire a contractor to extend the vent pipes to at least 6"- 12" would be ideal.

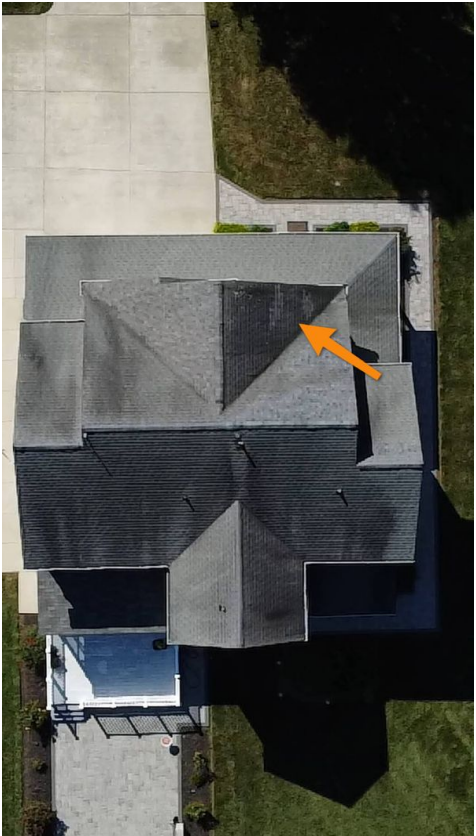
Location Perspective

There has been repairs to the roof covering. During a general home inspection, it is difficult to evaluate the cause, extent and quality of the repairs.

RECOMMENDATION: Monitor the area below the repairs to consider if additional action is required. Hire a qualified roofing contractor for an evaluation as needed.

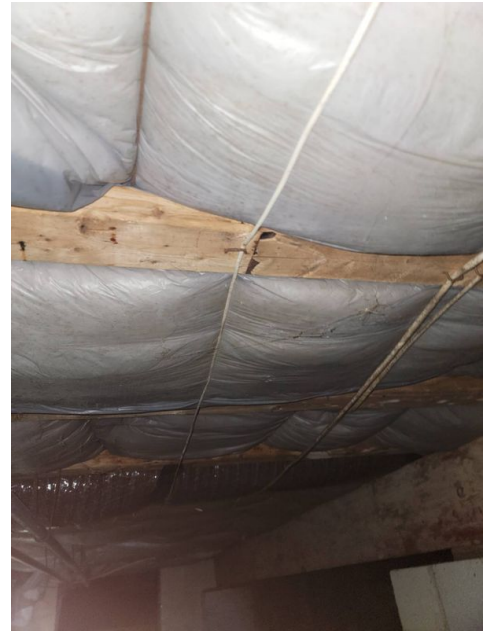
CRAWL SPACE

Covered with insulation: The flooring is covered with insulation. Therefore, the inspection is limited.

Very Little can be seen if Floor structure due to insulation

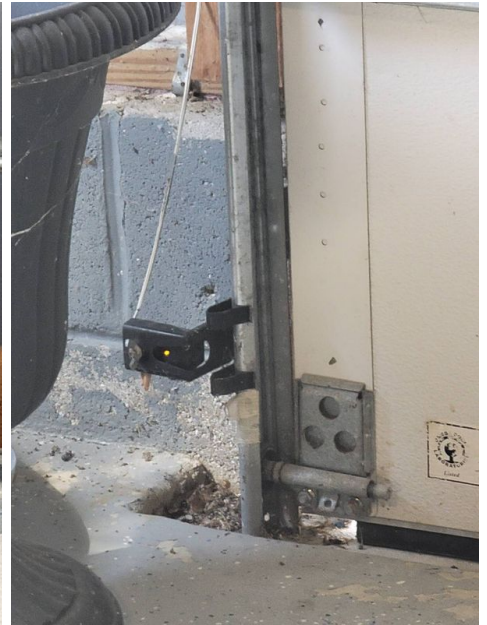
Photoelectric Auto reverse sensors  
(Unable to Test)

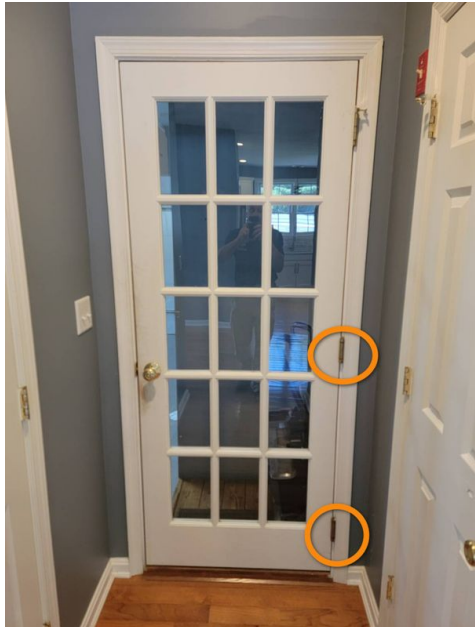
The self-closing hinges on the door between the attached garage and the living space is damaged or the tension has been removed. The door does not fully close on its own. This is a safety concern. It can allow gas fumes and carbon monoxide to enter the living space.

Location Perspective (Non Functional)

RECOMMENDATION: Adjust or replace the self-closing hinges.

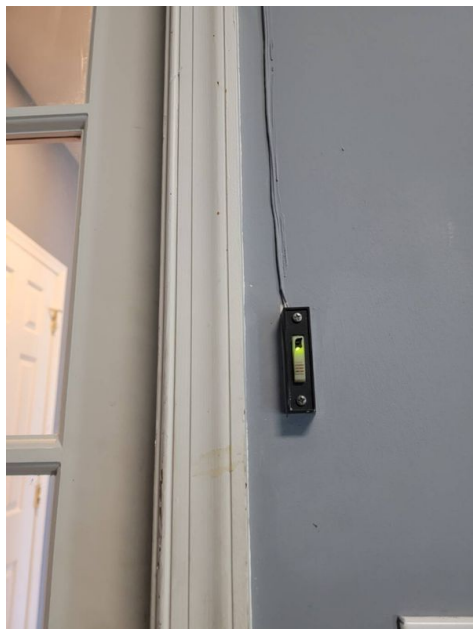
Button needs to be held to close

**RECOMMENDATION:** Hire a garage door contractor for an evaluation and to make repairs as needed. (Many times the opener needs the sensitivity adjusted).

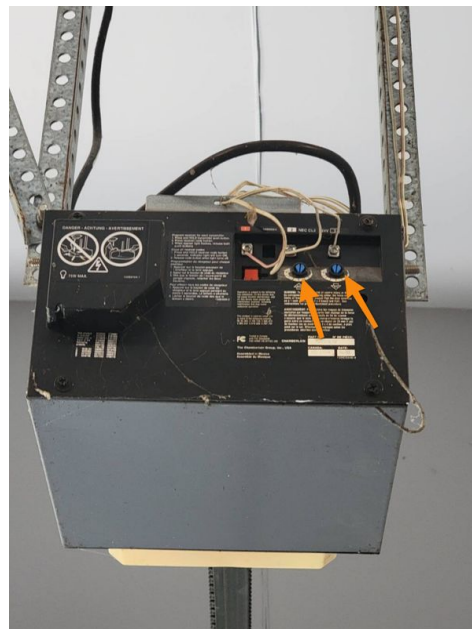
Sensitivity Adjustment for opener

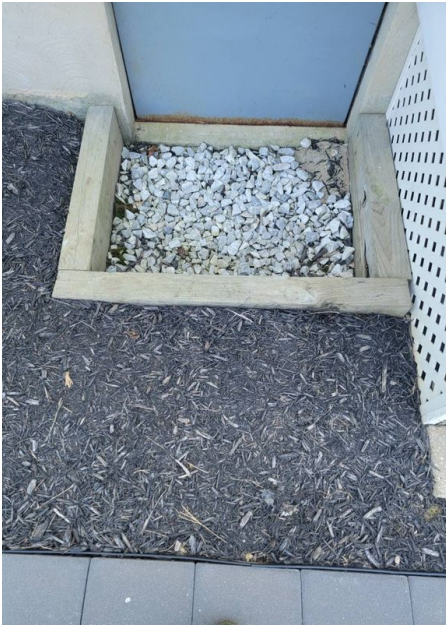
Ledt Side Window Well (Keep Clear) Maintenance

Window wells need to be continually cleaned of leaves and debris. As these break down, the water can't pass through the crushed rock so the water drains to the foundation footers as designed especially as homes become older. Installing the plastic covers over the window wells to assist with keeping them clear.

Keep clear of debris

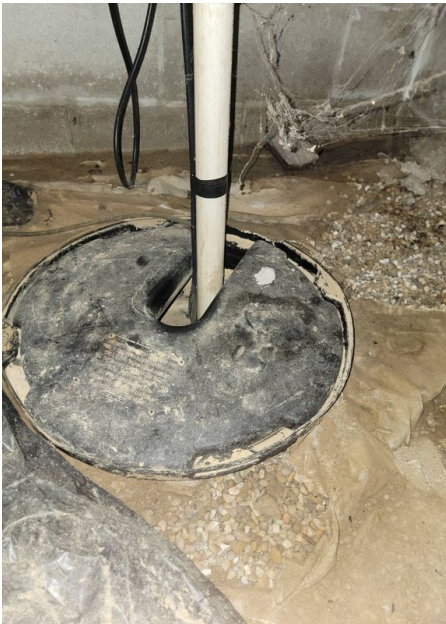
Ceawl Space Sump Pump

No battery back-up system, consider installing back-up system: The sump pump does not have a battery back-up system; it is dependent on electrical service. During inclement weather electrical service outages are more likely. This is also the most important time to have your sump pump working. Consider installing a battery back-up system.

Recommend Adding a battery backup

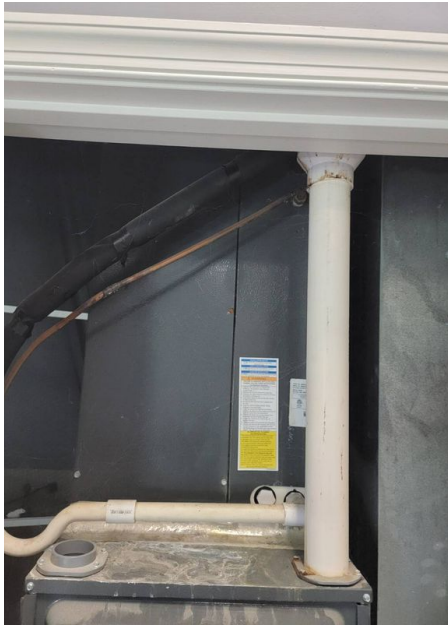
Supply Temperature (Cooling)See  
Comments

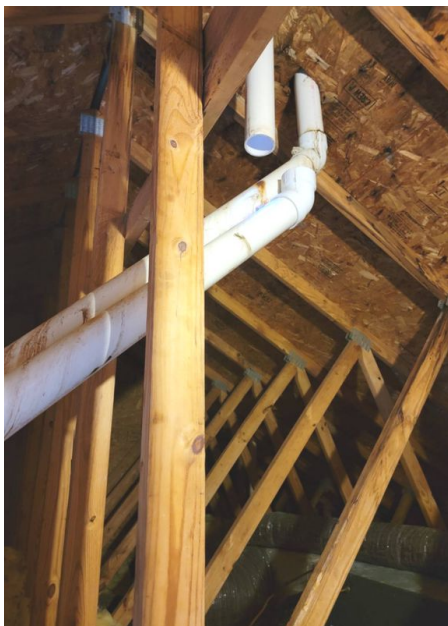
PVC Exhaust (See Comments)

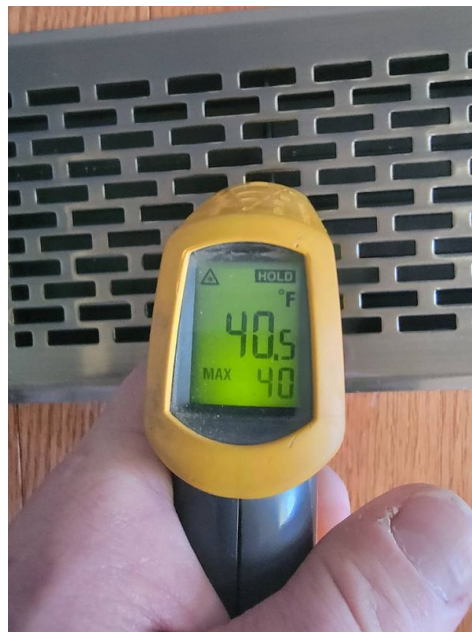
High Delta T (more than 24°F difference) means that the incoming temperature and outgoing temperature is excessively large. Could potentially be caused by low air flow across the coil, which could indicate a dirty filter, a fan set to an incorrect speed, a dirty evaporator coil or ductwork that is too small. Confirming any of these are beyond the scope of a home inspection. Rarely it can mean there is a sealed system issue, meaning either the refrigerant is slightly low or the indoor refrigerant metering device is restricted.

NOTE: Turned the AC off in the case of a restriction or low refrigerant. This could keep the proper oil return back to the compressor and allow it to burn out. This would be a much larger cost.

Supply Temperature Drop Excessive

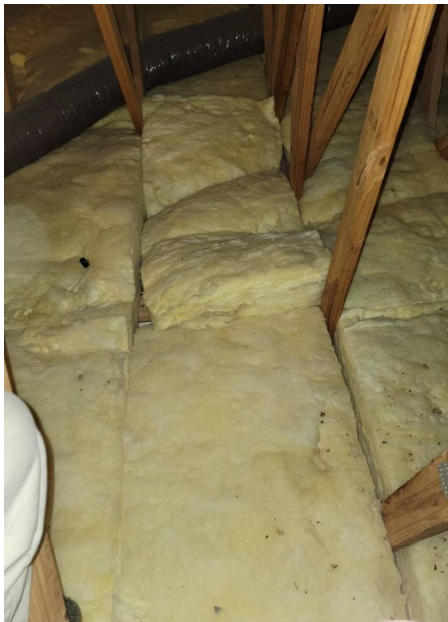
**Attic Insulation: The level of attic insulation is considered inadequate**

INFORMATION: The level of attic insulation is considered inadequate by current standards. Consider installing additional insulation in accordance with local guidelines to improve energy efficiency.

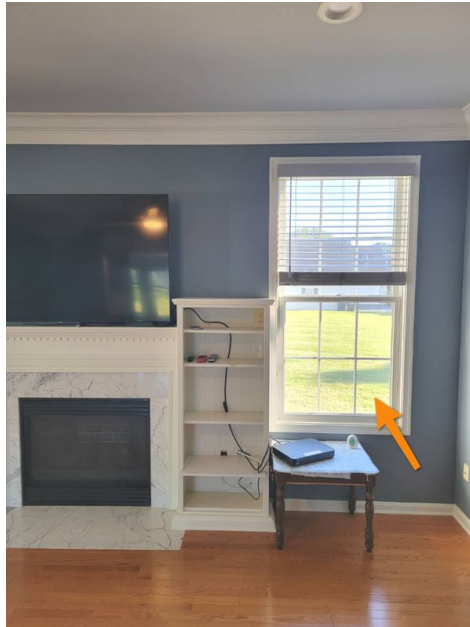
Location Perspective (Living Room)

One or more window sashes do not stay in the open position. The sash balances are damaged. This affects proper function. The window(s) can come crashing down and result in injury. This is a safety concern.

RECOMMENDATION: Hire a licensed window contractor to replace the window(s) as needed.

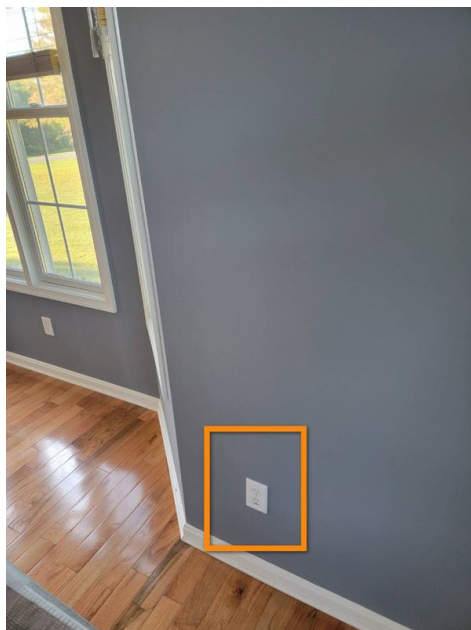
Dining Room (Left Wall of House)

Receptacles are loose in the wall or in their junction boxes. This is a safety concern. Loose receptacles can result in damaged or loose the wire connections.

RECOMMENDATION: Hire a licensed electrical contractor for an evaluation and to provide repairs as needed.

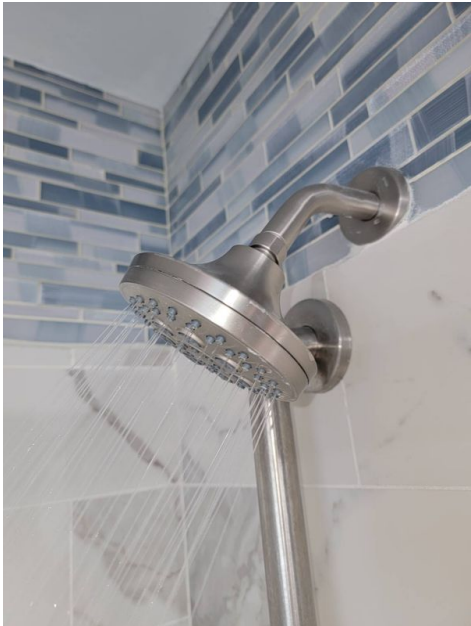
Good Water Pressure

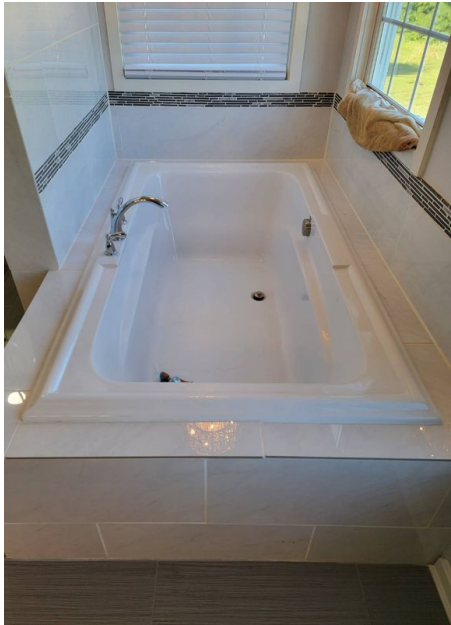
Master Tub Acceptable

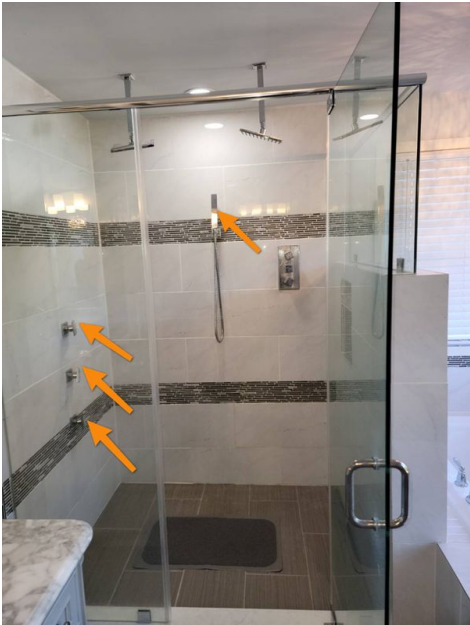
Master Shower Wand and Side Showerheads Functional

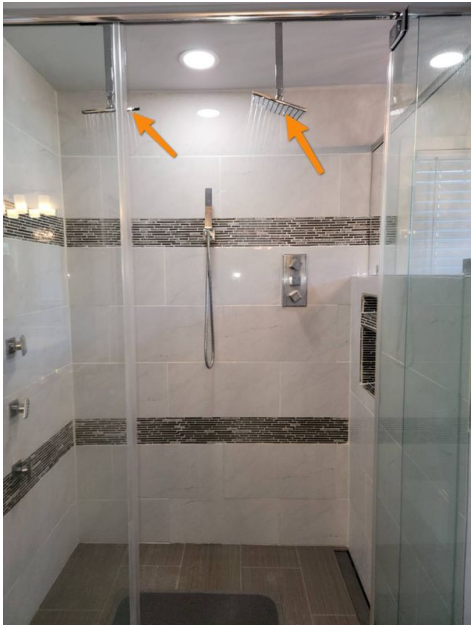
Both Top Showerheads Functional

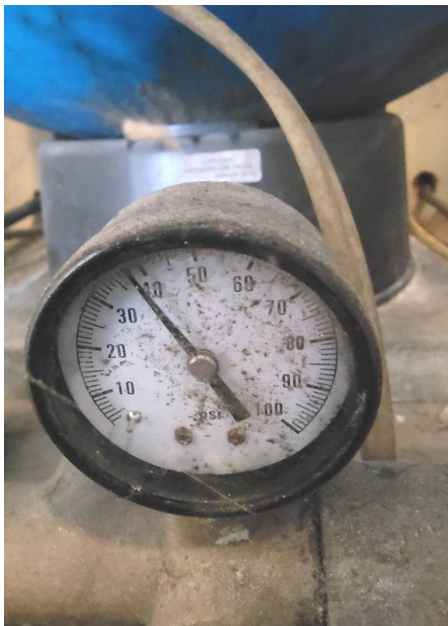
INFORMATION: Water pressure was within the acceptable range of 35 to 80 psi at the time of inspection.

Water Pressure (Acceptable/Within Spec)

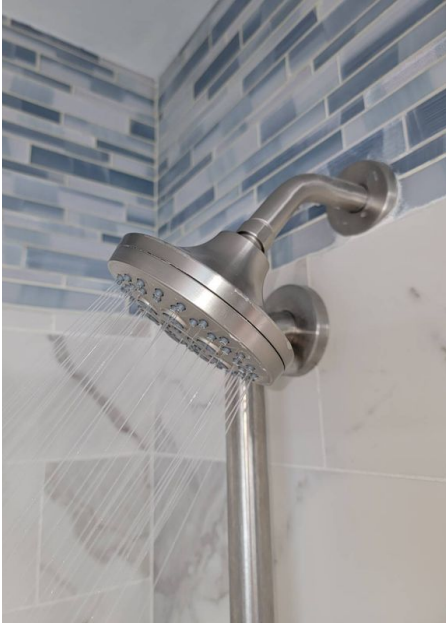
The water pressure over-all is good. It passed the "functional flow." test. This test is determined by running water in the sink(s) and shower while toilet is flushed. If shower spray pressure remains, it passes. If it drops significantly it fails and should be looked into further.

All Showerheads Passed Functional  
Flow Test

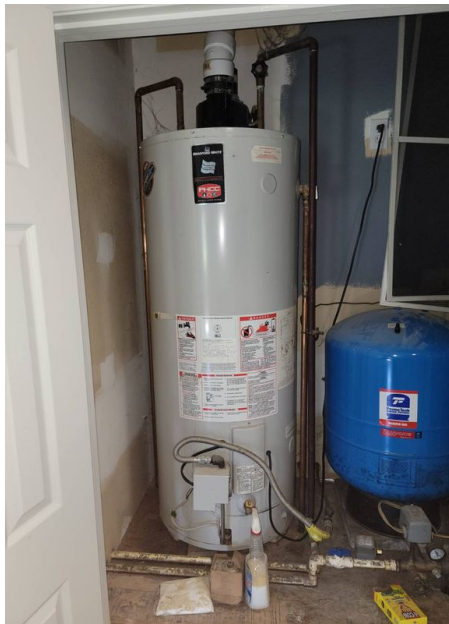
High Efficiency Water Heater (Propane)

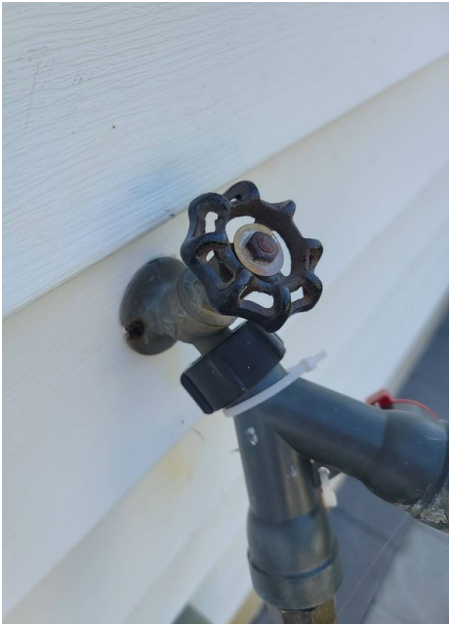
Rear Hose Spigot Acceptable

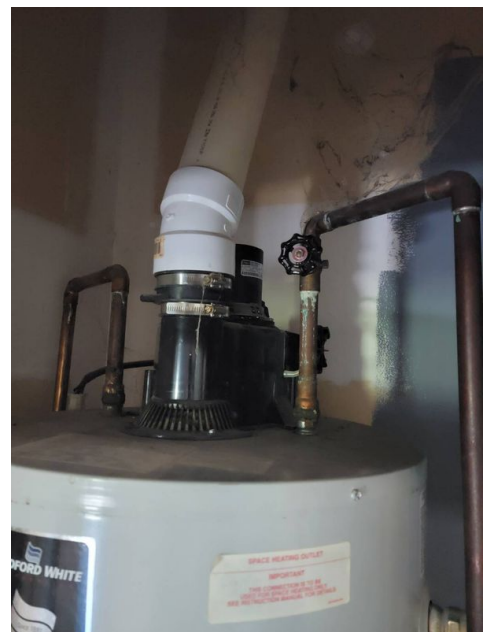
High-efficiency unit, sealed components not inspected: The water heater is a high-efficiency unit and includes components which are sealed and cannot be inspected.

Sealed High Efficiency Parts

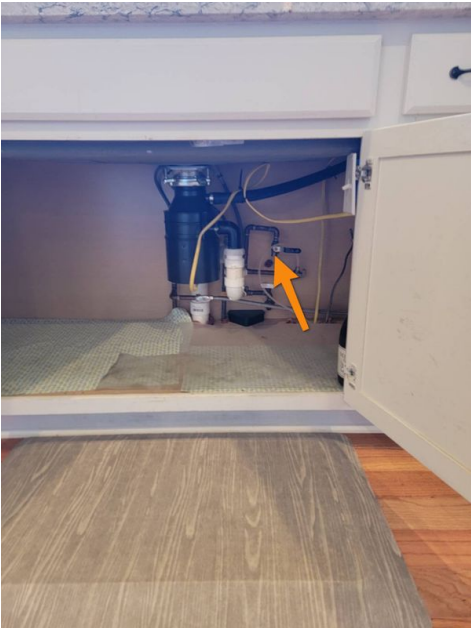
Location Perspective (Under Kitchen Sink)

The water supply pipe is not capped off properly. It has a ball valve being used as a shut-off. Moving cleaning products in and out can accidentally bump the valve causing it to open. This could cause water damage.

RECOMMENDATION: Hire a plumber to properly install a cap after the valve.

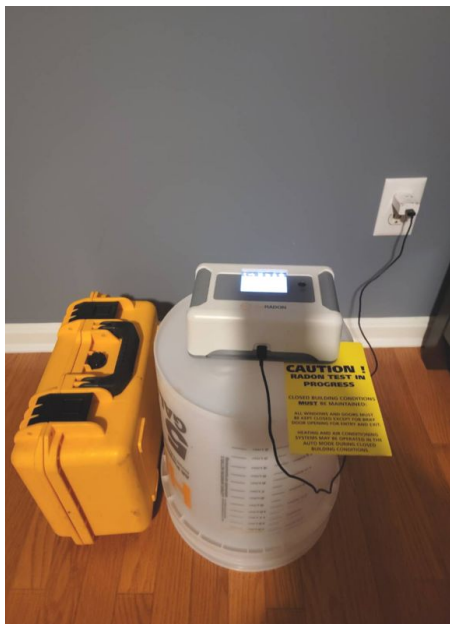
Radon Test in Progress (Friday 9th  
8:21 pm)

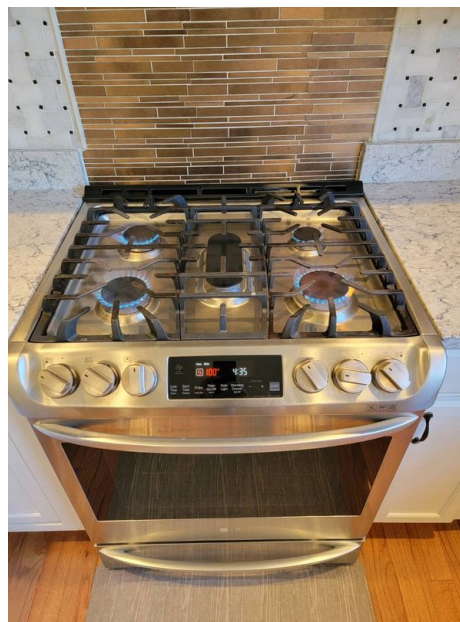
All Top Burners Functional

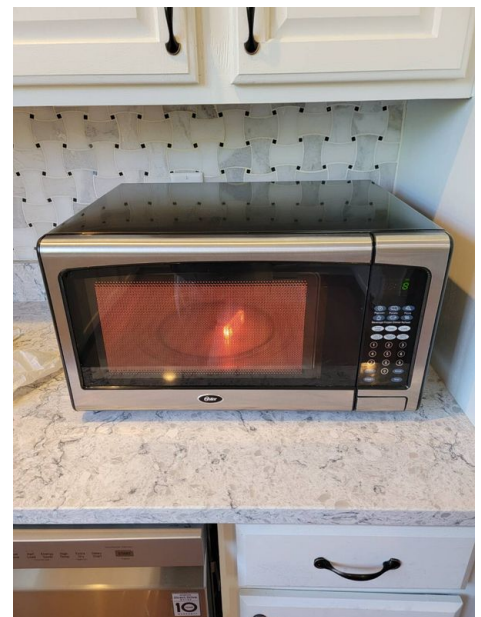
Microwave Functional

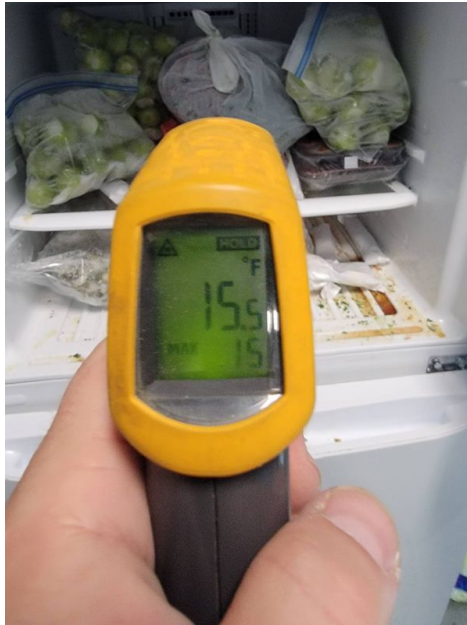
Freezer Section Below Freezing

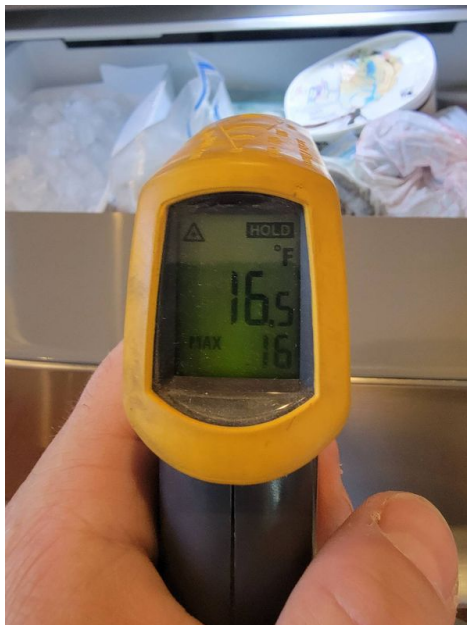
Refrigerator in Kitchen Acceptable

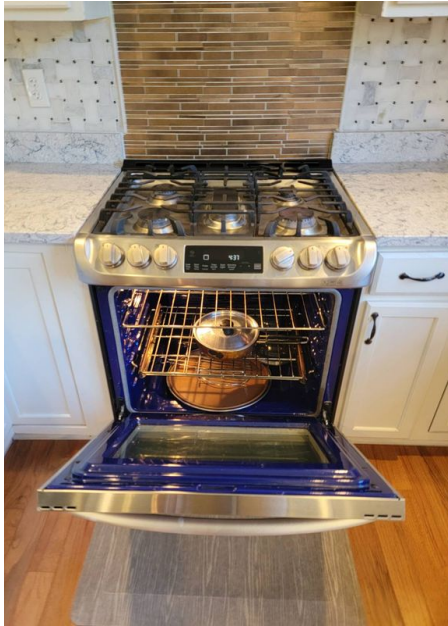
Oven Section

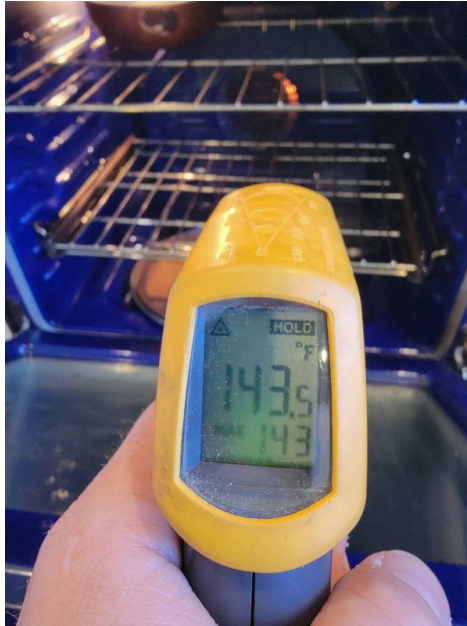
Convection Bake Functional

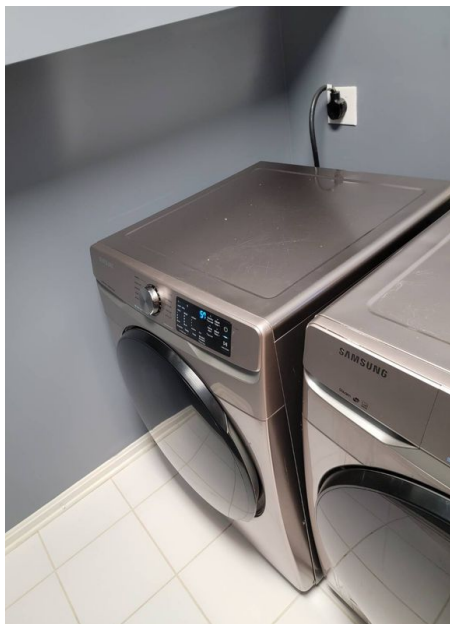
Dryer Functional

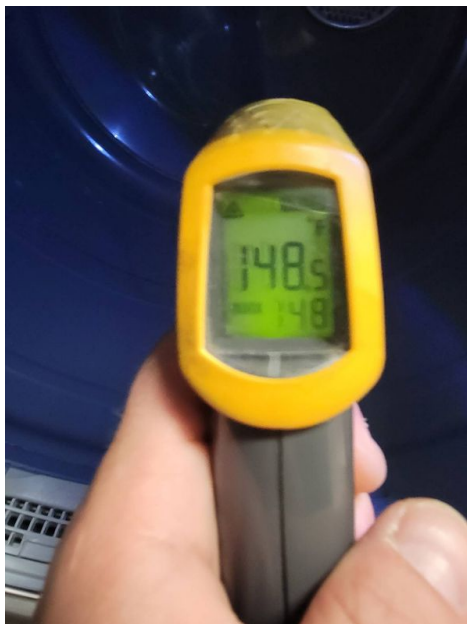
Dryer Heating

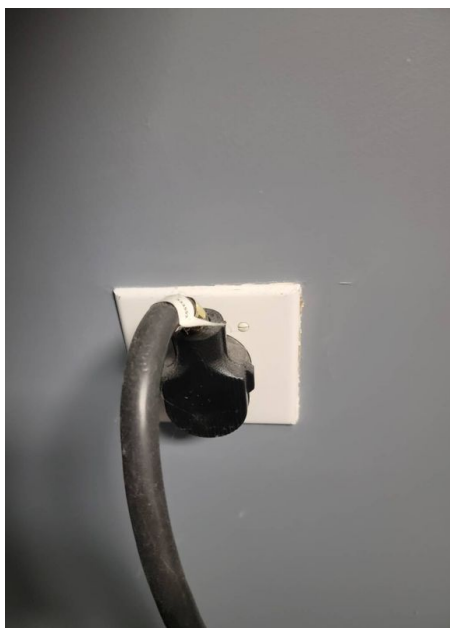
Newer 4 Prong Receptacle for Dryer
